Although a direct strike of overhead lines avoided , 400v lines arc to tipper at delivery site

| LOCATION: | CONSTRUCTION/DELIVERY SITE | ALERT STATUS: | High Potential |
| SUB ACTIVITY: | PRODUCT DELIVERY | INCIDENT No: | 03615 |

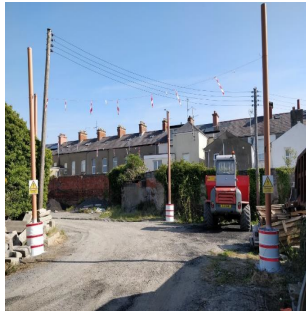
Goal posts, signage and bunting added at the site

- A company memo was issued highlighting the incident, the importance of treating each and every tipping situation with the same level of caution and the correct procedure for disposing of waste materials left over from site.
- The procedure for dealing with excess materials from site was added to company induction pack.
- A safety alert was circulated to all personnel and added to toolbox talks manual.
