Fire – Dredger drive step-up high voltage transformer

AGGREGATE DREDGER

03622

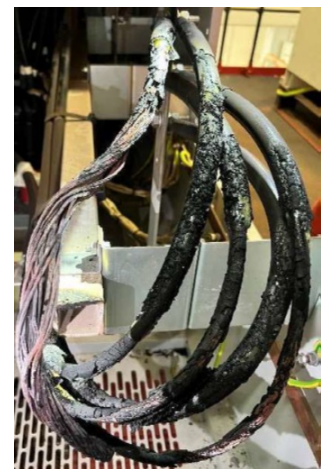
A UK marine aggregate dredger was 2-hours into its regular dredging operation when a fire alarm sounded on the bridge activated by a detector in zone 8 which covered a number of compartments. Activation was due to smoke being generated by smouldering electrical cable cores within the pump drive step-up voltage transformer located in the pump-motor room within fire detection Zone 8.

The smouldering cables were successfully extinguished by the ships crew using portable CO₂ extinguishers, with no injuries to personnel and no damage to the transformer or any other equipment.

The cable routing and attachment to the framing gave rise to chaffing of the cable core insulation at the bend radius (probably caused by vessel vibration), allowing the conductors to be exposed, generating heat leading to further deterioration of the cable core insulation. All other cabling and terminal connections were found to be in good order.

- Improved routing of the cable cores and protection of likely chaffing points.

- Always fully investigate for the source of a fire alarm – avoid speculation of potential causes;
- CCTV camera coverage could aid in the early location of the smoke;
- Particular attention should be given to cable routing and fixing during renewal or installation of new equipment requiring electrical power supplies.
