# Ship crane cable failure

**LOCATION:** AGGREGATE DREDGER  
**ACTIVITY:** LIFTING  
**SUB ACTIVITY:** NO SUB ACTIVITY AVAILABLE

**ALERT STATUS:** Normal  
**DATE ISSUED:** 08/09/2022 17:51:51  
**INCIDENT No:** 03629

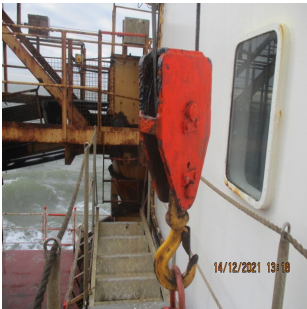
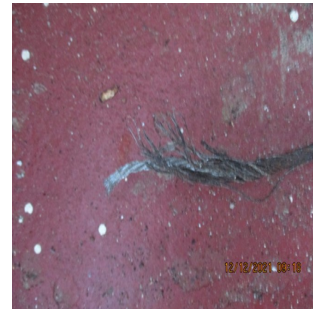
When raising the empty crane hook, to re-position the crane and re-connect the gangway, the crane wire parted, causing the crane hook to fall to the deck.

- When the crane wire was being hoisted, the winch stalled unexpectedly. The crew member lowered the hook briefly, then re-tried hoisting, when the wire parted.
- The crane wire had been fitted in 2020, and regularly maintained and inspected by the crew. The last inspection by the lifting gear contractor was in August 2021.
- The crane wire had not been overloaded.
- The investigation indicates that the crane wire may have been allowed to become slack at some time previously, leading to a riding turn on the drum.
- Good safety practices on board, and a high level of safety awareness of the crew meant no-one was under the hook as it fell.

- Lifting operations supervised by competent / authorised persons.
- Robust inspection and maintenance schemes.
- Reporting of any defects, near misses or hazards.
- Maintain exclusion zones around any lifting operations and suspended loads, including crane components.

- Everyone knows the importance of remaining clear of suspended loads, but a falling empty crane hook could also cause injury to someone stood below.
- When machinery or equipment stops unexpectedly, it should be checked over prior to re-starting. Machinery doesn't stop for no reason, even if the reason is not immediately obvious to the operator.
- Never walk under suspended loads, including crane hooks themselves and always ensure suitable exclusion zones around lifting operations
