# Fatal 3 - Operator slips whilst checking installation of new screens

QUARRY

INCIDENT No:

03637

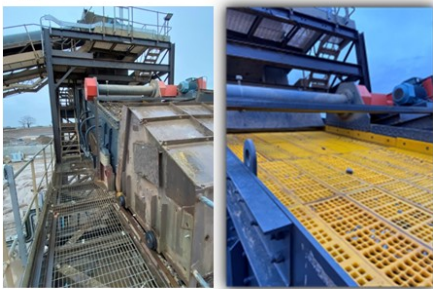
- Site operatives were to inspect screen mats on the newly installed screen and install a rubber curtain.
- A risk assessment was obtained, and a **STOP** assessment completed.
- The injured person accessed the screen and slipped as he moved on the screen and resulted in damage to his leg muscle

- The risk assessment obtained was not for the task being carried out.
- The STOP assessment didn't consider all of the hazards involved with the task.
- Access to and from the screen to carry out the task was poor, and no control measures were put in place to control fall from height risks.
- The plant is fitted with effective recordable CCTV which supported the IP / site team to investigate the incident.

- When reviewing a risk assessment, all hazards must be accurately identified, and suitable control measures implemented.
- The risk assessment for a task must be suitable and accurate to the task being carried out.
- Methods of access to and from a screen must be assessed to ensure all hazards are identified and fall from height risks are controlled.
