Angle Grinder Kick Back

CEMENT PLANT
MAINTENANCE & HOUSEKEEPING
N/A

ALERT STATUS: Normal
DATE ISSUED: 24/04/2013
INCIDENT No: 00364

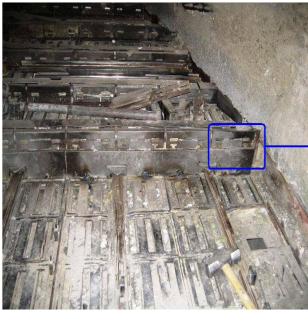
An experienced operator was using a 9 inch angle grinder to cut out lower stainless steel welding fillets in the clinker cooler.

Fillet Being Cut

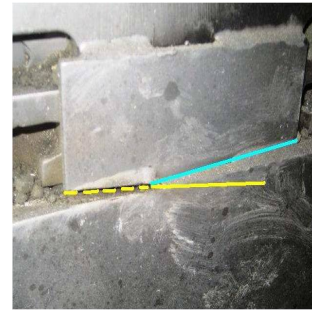
Cut Out of Alignment

used in a near vertical position where a consistent even cut through the stainless steel welds was possible. Therefore the machine was used in a more horizontal plane which resulted in an off-horizontal cut, that in turn resulted in the blade snagging and kicking back.

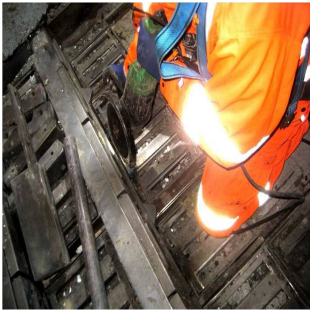
As the operator approached the cooler wall he couldn't operate the grinder vertically, so moved to position where he was using it by holding the grinder horizontally. In order to access the last two welds he remained standing but stooped in order to hold the angle grinder in a more horizontal plane as the previously steeply inclined position could not be accommodated so close to the cooler wall.

There was insufficient space available close to the cooler wall to allow the 9 inch angle grinder to be

Cutting Position

The use of 9 inch angle grinders was suspended until a full evaluation of the need to use this type of equipment has been made (and further 4½ inch angle grinders were sourced).

Subsequently if there is a call for the use of a 9 inch angle grinder, then a task specific risk assessment must be completed: and the 9 inch angle grinder will only be permitted for the use of that operation only.

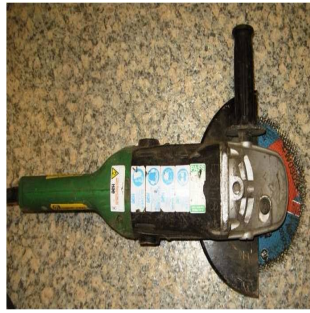
During the use of the grinder horizontally, the blade snagged in the steel being cut and kicked back towards the user. As the grinder kicked back the rotating blade caught his left thigh, resulting in a laceration about 60mm in length and 25mm deep, that required immediate first aid and hospital treatment.

Recovered Grinder
