Fatal 1 - Failure to properly isolate agitators at block plant during maintenance work

LOCATION: CONCRETE PRODUCTS PLANT
ACTIVITY: GUARDING AND ISOLATION
SUB ACTIVITY: NO SUB ACTIVITY AVAILABLE

ALERT STATUS: Normal
DATE ISSUED: 22/06/2023 12:47:56
INCIDENT No: 03645

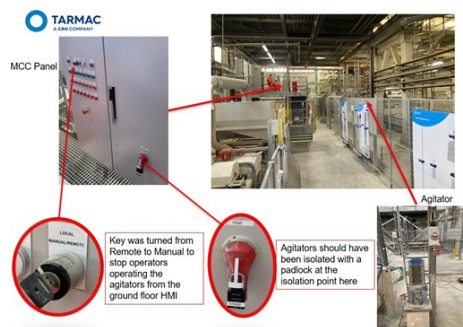
During a yearly shutdown in April 2022 at a block plant, work was planned to be carried out by the operators to dig out the vac crust pit located under the vac and cutting line. Operators had taken out the castell key to enter the vac area and put into the lock box. All the operators individually locked off to the box securing the area to work in, they then entered the area and began to dig out the crust pit. While carrying out a walk of the area, a safety rep and maintenance manager identified the agitators within the area were switched off (To "Manual") on the MCC panel on the mezzanine floor but the panel was not fully isolated, and no isolation document had been completed.

Although a LOTOTO SOP for this task was present and clear, including all the isolation points, the responsible person had failed to own the isolation process and to make sure all the measures were in place before the work commenced.

- Share this incident with all sites
- Review site isolation process and training in line with company standard, and site shut down procedure.
- Find engineering solutions to simplify the isolation process in line with best practice.
