# Fatal 1 - LOTOTO - Failure to correctly follow isolation procedure when undertaking maintenance work

**LOCATION:** CONCRETE PRODUCTS PLANT  
**ACTIVITY:** GUARDING AND ISOLATION  
**SUB ACTIVITY:** NO SUB ACTIVITY AVAILABLE

**ALERT STATUS:** Normal  
**DATE ISSUED:** 22/06/2023 13:20:06  
**INCIDENT No:** 03646

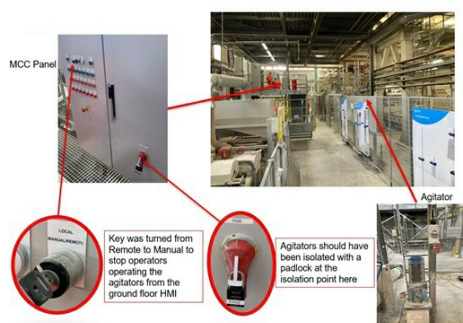
In April 2022 a plant was in the process of carrying out its yearly engineering shutdown. One of the planned tasks was for operators to dig out the vac crust pit located under the vac and cutting line. The operators had taken out the castell key to enter the vac area and put into the lock box. All the operators individually locked off to the box securing the area to work in, then entered the area and began to dig out the crust pit. While carrying out a walk of the area, a safety rep and maintenance manager identified the agitators within the area were switched off (To "Manual") on the MCC panel on the mezzanine floor but the panel was not fully isolated, and no isolation document had been completed.

Although a LOTOTO SOP for this task was present and clear, including all the isolation points, the responsible person failed to own the isolation process and to make sure all the measures were in place before work commenced.

- Share this incident with all company sites
- Review site isolation process and training in line with the company standard, and site shut down procedure
- Find engineering solutions to simplify the isolation process in line with best practice
