# Over Turned 1 tonne Dumper

LOCATION:	CONSTRUCTION/DELIVERY SITE	ALERT STATUS:	Normal
ACTIVITY:	PRODUCTION AND PROCESSING	DATE ISSUED:	24/05/2013
SUB ACTIVITY:	ASPHALT & COATED STONE	INCIDENT No:	00365

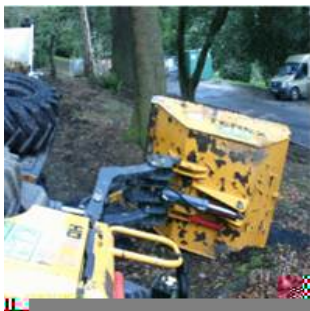
As one of the 1 tonne dumpers had tipped its load of asphalt into the paver hopper, the dumper driver reversed away from the paver (across a gradient), with the dumper bucket still in it's elevated position: and the dumper overturned due to the raised centre of gravity and narrow wheel track. Fortunately, the driver was not injured during the incident although he was slightly shaken.

Over turned dumper

The gradients were measured during the investigation and were found to vary between 1:5 to 1:15, running both along and across the footpath. It also became apparent that control measures identified during previous dumper incident investigations had not been implemented.

- The company has banned all 1 tonne skip loader dumpers from its operations and alternatives are being sought e.g. tracked 1.5 tonne dumpers, JCB 2CX, 3 tonne dumper etc.
- The gradients on site must be measured prior to work commencing, and checks must be made with the plant hire companies and operator's hand books, to make sure that the gradients do not exceed the plants' safe operating capabilities.
- Adequate control measures must be developed and included in the Site/Task specific Risk Assessment, added to the Job Briefing Sheet/Safe System of Work and adequately communicated to all personnel on site.
- If at any time, anyone on site is of the opinion that the work being undertaken is unsafe, they should raise their concerns with their

supervisor/line manager and seek to find a safer alternative method of working.
