Over Turned 1 tonne Dumper

LOCATION:	CONSTRUCTION/DELIVERY SITE	ALERT STATUS:	Normal
ACTIVITY:	PRODUCTION AND PROCESSING	DATE ISSUED:	24/05/2013
SUB ACTIVITY:	ASPHALT & COATED STONE	INCIDENT No:	00365

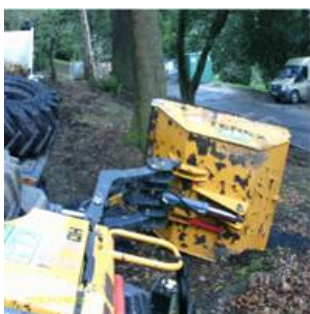
As one of the 1 tonne dumpers had tipped its load of asphalt into the paver hopper, the dumper driver reversed away from the paver (across a gradient), with the dumper bucket still in it's elevated position: and the dumper overturned due to the raised centre of gravity and narrow wheel track. Fortunately, the driver was not injured during the incident although he was slightly shaken.

Over turned dumper

- The company has banned all 1 tonne skip loader dumpers from its operations and alternatives are being sought e.g. tracked 1.5 tonne dumpers, JCB 2CX, 3 tonne dumper etc.
- The gradients on site must be measured prior to work commencing, and checks must be made with the plant hire companies and operator's hand books, to make sure that the gradients do not exceed the plants' safe operating capabilities.
- Adequate control measures must be developed and included in the Site/Task specific Risk Assessment, added to the Job Briefing Sheet/Safe System of Work and adequately communicated to all personnel on site.
- If at any time, anyone on site is of the opinion that the work being undertaken is unsafe, they should raise their concerns with their

supervisor/line manager and seek to find a safer alternative method of working.

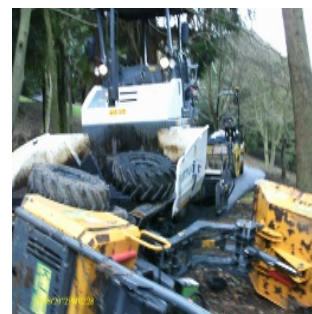
Over turned dumper
