TRANSPORT - Fatal 6 - Concrete mixer loss of drum

LOCATION:	ON-HIGHWAY	ALERT STATUS:	Normal
ACTIVITY:	TRANSPORT & LOGISTICS / DELIVERY	DATE ISSUED:	11/07/2023 21:18:48
SUB ACTIVITY:	DELIVERING READYMIX	INCIDENT No:	03650

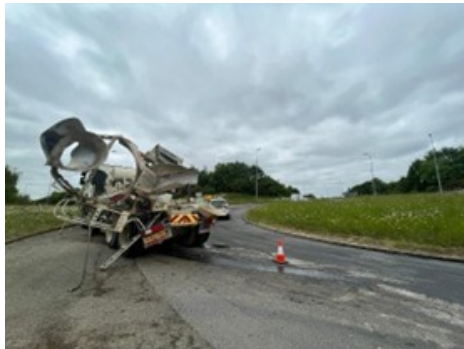
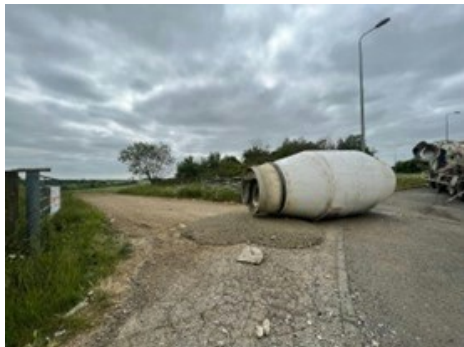
In June 2023 a third party owned concrete truck mixer was making a delivery, the vehicle suffered a significant structural failure of the mixer chassis/A frame. The failure resulted in the mixer drum becoming detached from the vehicle and coming to rest at the side of the carriageway.

There was no one harmed during the incident and no other road users were in the vicinity of the truck at the time, which was brought to a halt safely. All spilled fluids and concrete from the drum were contained in the immediate vicinity and cleared up shortly after the event by specialist contractors.

- A forensic examination of the truck was completed by independent specialist technicians who concluded that:
 - The concrete mixer sub-frame snapped suddenly.

- The failure initially occurred at a weakness in the sub-chassis which had been previously welded for a repair in 2019.
 - The weld had been carried out by a previous owner and not highlighted to the current haulier.

- The weld had weakened over time and eventually failed resulting in the incident.

- Immediately after the incident all the truck fleet dedicated to a major project were inspected, initially by their drivers/haulier and then by vehicle mechanics to confirm similar defects were not present.

- The remainder of the RMX fleet has been visually inspected by the company's transport team checking mixer bodies and their chassis for visual signs of cracking or deterioration.

- Operators should ensure that daily driver pre-start check sheets specifically include key structural areas like the A frame chassis.
- McFee have agreed to digitise their operator's manual and will issue QR codes, to be fixed to mixers they have manufactured, which will enable anyone to access the latest operator's manual.

- All hauliers must inform their service providers to carry out a thorough inspection of mixer drums, bodies, and chassis by a competent mechanic on their vehicles at the next 6 weekly safety inspection.

- Any repair work carried out to mixer bodies, or indeed elsewhere on the truck, should be listed & passed on to future owners so as correct focus can be given to potential future weak spots.
