# Slip, trips and falls - operator cut on knee following trip in yard

<b>LOCATION:</b>	<b>DEPOT</b>	<b>ALERT STATUS:</b>	<b>Normal</b>
<b>ACTIVITY:</b>	<b>MANUAL HANDLING AND STORAGE</b>	<b>DATE ISSUED:</b>	<b>30/07/2023 20:50:22</b>
<b>SUB ACTIVITY:</b>	<b>AGGREGATES</b>	<b>INCIDENT No:</b>	<b>03656</b>

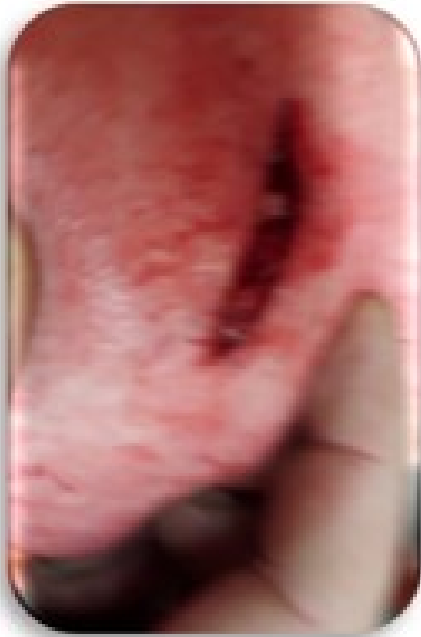
The IP began to offload the a vehicle, it was dark due to the time, but the yard was floodlit. He was offloading sandbags onto the pallets where the sandbags are stored. A gully had been left on the floor next to the pallet by sub-contractors. Not seeing the gully whilst walking and fell causing a gash to his knee. The resulting injury was a cut to the knee that required stiches at the local A&E.

- Area was lit by flood lights however shadows cast by the vehicle may have caused the object to be less visible than normal
- The gully had been left on the floor by a sub-contracting gang working for contracting
- The driver had not inspected the area before beginning to work in the area

Gully left along vehicle  
by sandbag area

- Lighting of yard areas and outdoor workspaces to be inspected and critical areas of pedestrian movements and work areas are illuminated sufficiently taking in to account any shadows that me be initiated by other objects
- Daily inspections of work areas are undertaken and any unsafe conditions or concerns to be raised through line management and recorded on Intellex
- Housekeeping inspections are to be undertaken regularly to ensure equipment is stored in a safe manner and any items or areas not meeting minimum standards are improved and those with the responsibilities are held accountable
- Areas of specified equipment is sufficiently identified by clear signage and instruction
