Wheel Rim Failure

ALERT STATUS: Normal
DATE ISSUED: 31/07/2013
INCIDENT No: 00366

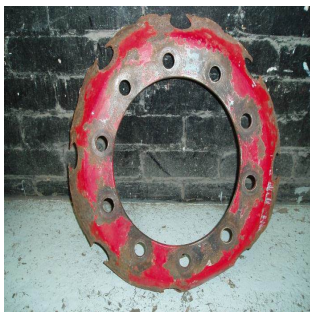
Wheel Flange

The wheel was manufactured in 1998, so was approximately 15 years old. The wheel also had significant corrosion on, and around the weld that joins the wheel flange to the wheel rim.

An immediate fleet survey took place, and any wheels showing signs of corrosion on or around the weld, were replaced.

As wheels are date stamped the second phase is to replace any wheel that is over 10 years old regardless of condition.
