Fatal 5 – Employee sustains face injuries whilst assisting in the movement of a suspended load with a telehandler.

LOCATION:	WHARF	ALERT STATUS:	Normal
ACTIVITY:	LIFTING	DATE ISSUED:	29/11/2023 10:15:26
SUB ACTIVITY:	NO SUB ACTIVITY AVAILABLE	INCIDENT No:	03677

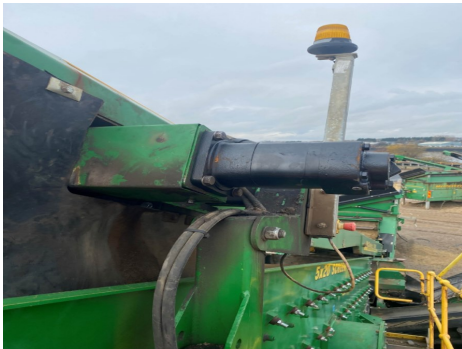
The foreman had been advised to get assistance from a site operative. The weight of the motor was supported by a telehandler. The incident occurred when the final bolt was released from the motor. As the motor was pulled back, it snagged on the torque plate brace. The operative tried to release the snag and the motor freed and then, because it was attached to strops suspended from the telehandler, it rotated anti clockwise hitting the operative's safety helmet, which pushed into his forehead causing a laceration. The motor continued to rotate, with the torque plate striking the right-hand side of the operative's nose. He was taken to hospital where he required 3 stitches.

Image of motor in position

- Specific RAMS and Lift Plan should have been in place to identify the most appropriate method of work, and ensure when the task didn't go to plan, it was stopped allowing the RAMS and Take 5 to be reviewed.
- The weight of the motor was being supported by a strop wrapped around the motor attached to the telehandler. The foreman operating the telehandler and operative were communicating through an open window. Use of a Hiab may have improved communication and allowed the person guiding the lift to stand on the work platform; alternatively, use of a pull lift would have provided greater control of the tension placed on the motor.
- Rather than attempting to release the motor by hand, use of a guide rope would have avoided the need to be "in the line of fire".

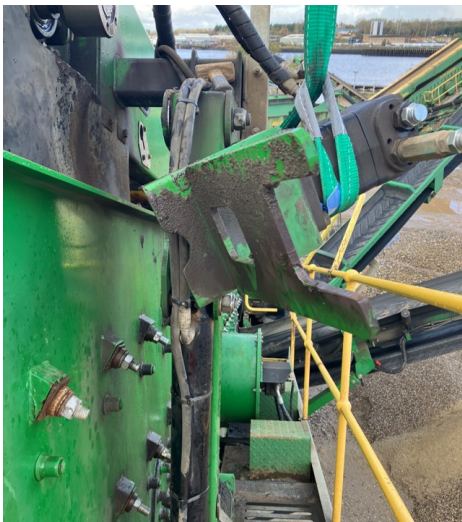
Image of motor suspended
