Battery Explosion

LOCATION:	CEMENT PLANT	ALERT STATUS:	Normal
ACTIVITY:	MAINTENANCE & HOUSEKEEPING	DATE ISSUED:	01/08/2013
SUB ACTIVITY:	N/A	INCIDENT No:	00368

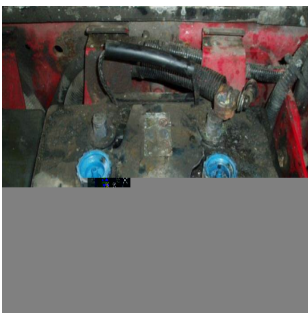
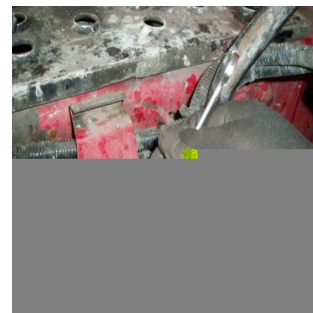
An LGV vehicle battery top exploded when the hydrogen gas it was venting, was ignited by sparks, caused by a spanner accidentally touching earth.

What happened: A contractor was carrying out a modification to a catwalk. As this work involved welding to the chassis, the battery was disconnected. Once the work was completed the battery was reconnected, and the spanner accidentally touched the chassis, causing an arc. This in turn ignited the hydrogen venting from the battery, causing it to explode.

It would not be expected for a battery to give off gas when not being charged, however in this instance the vehicle was started and moved into the workshop, this will have drained the batteries and caused the vehicle to start charging.

Once in the workshop the positive (+) terminal was disconnected, and the batteries were covered with rags to protect them from welding/cutting & grinding. It is possible that the rags did not allow the gas to dissipate and built up during the time it took to carry out the modification. Never cover the batteries with rags, should the batteries need protection, replace the cover, or remove them.

Disconnecting/reconnecting the positive (+) terminal, of the battery is not considered the correct method, as any contact with an earth will cause a spark.

If the negative (-) was disconnected first then any

accidental touching of the chassis would not result in a short circuit. Always remove the negative (-) terminal first!
