Battery Explosion

LOCATION:	CEMENT PLANT	ALERT STATUS:	Normal
ACTIVITY:	MAINTENANCE & HOUSEKEEPING	DATE ISSUED:	01/08/2013
SUB ACTIVITY:	N/A	INCIDENT No:	00368

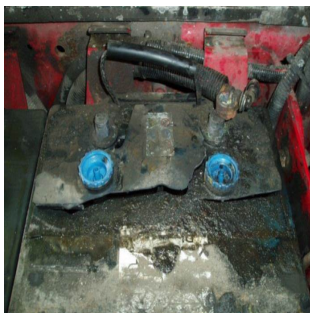
An LGV vehicle battery top exploded when the hydrogen gas it was venting, was ignited by sparks, caused by a spanner accidentally touching earth.

What happened: A contractor was carrying out a modification to a catwalk. As this work involved welding to the chassis, the battery was disconnected. Once the work was completed the battery was reconnected, and the spanner accidentally touched the chassis, causing an arc. This in turn ignited the hydrogen venting from the battery, causing it to explode.

It would not be expected for a battery to give off gas when not being charged, however in this instance the vehicle was started and moved into the workshop, this will have drained the batteries and caused the vehicle to start charging.

Once in the workshop the positive (+) terminal was disconnected, and the batteries were covered with rags to protect them from welding/cutting & grinding. It is possible that the rags did not allow the gas to dissipate and built up during the time it took to carry out the modification. Never cover the batteries with rags, should the batteries need protection, replace the cover, or remove them.

Disconnecting/reconnecting the positive (+) terminal, of the battery is not considered the correct method, as any contact with an earth will cause a spark.

If the negative (-) was disconnected first then any

accidental touching of the chassis would not result in a short circuit. Always remove the negative (-) terminal first!
