TRANSPORT – Fatal 6 - Tipper lorry roll over during the unloading of a bulk fuel material

LOCATION:	LIME & SLAG PLANTS	ALERT STATUS:	Normal
ACTIVITY:	TRANSPORT & LOGISTICS / DELIVERY	DATE ISSUED:	30/11/2023 17:24:43
SUB ACTIVITY:	DELIVERING FUELS & LUBRICANTS	INCIDENT No:	03680

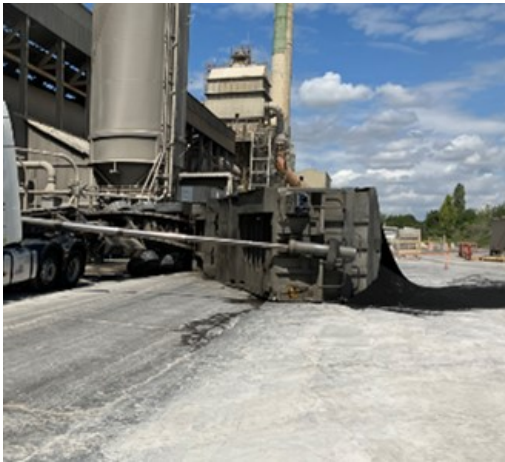
The lorry overturned during the start of its off-loading procedure. The incident was captured on video. Fortunately, nobody was injured in this high potential incident.

Damage was sustained to the trailer unit, plus some spillage of the load – the area was cleaned and returned to site standards.

- An exclusion zone to be established around the designated tipping location to prevent personnel and vehicle access within the 'danger area'.
- Ground at designated tipping area checked (confirmed) to ensure level and solid.

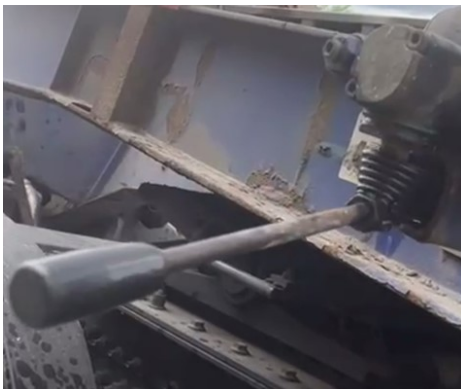
Please see below an image of the faulty lever mechanism

- Failure of tipping valve lever to return to the neutral position after operation.
- The lever was found to be defective ('wobbly') and the rubber boot around the lever handle had split allowing dirt to enter the mechanism.

- Inspect tipping valves on all hauliers' trailers with similar mechanism.
- Communicate this incident to all tipping vehicle delivery drivers and site personnel to ensure they understand the root cause and are extra vigilant (Haulier)

- In the short term, a company representative to assist the tipping of all fuel tipping trailers.
- All other tipping activities reviewed.
- Ensure check of tipping valve operation is included in driver daily checks from now on and add a more thorough check by a mechanic to trailer annual maintenance check or similar (Haulier)

- Modern controls only operate when the lever is pushed to raise or lower and should return to neutral automatically as soon as hand is taken off the control.
