Fatal 1 - Socomec safety isolator - operator found he was able to remove padlock whilst isolated

LOCATION:	ASPHALT/COATING PLANT	ALERT STATUS:	High Potential
ACTIVITY:	GUARDING AND ISOLATION	DATE ISSUED:	16/01/2024 13:55:49
SUB ACTIVITY:	NO SUB ACTIVITY AVAILABLE	INCIDENT No:	03690

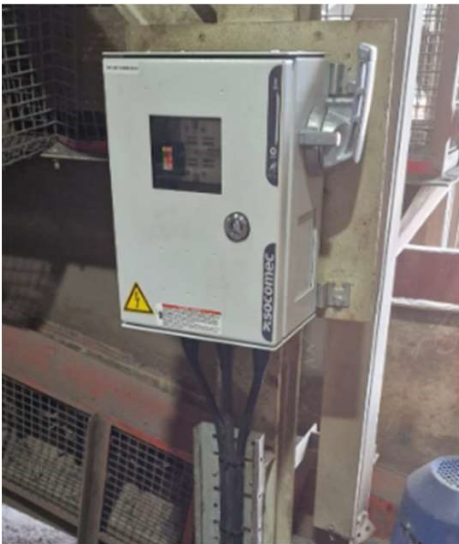
Whilst trying out an isolation at an asphalt plant during a major regeneration project, a new Socomec safety enclosure isolator was discovered to be faulty, meaning the locked padlock could be removed whilst the system was isolated.

An asphalt plant engineer discovered whilst 'trying out' his isolation, that it was possible to remove his locked padlock from the isolator by depressing the handle past its 'OFF' position.

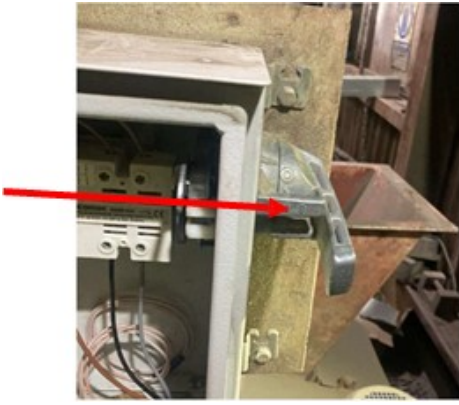
In the 'OFF' position, the isolator handle is turned downwards, and a lock applied to prevent the handle being switched back to 'ON'. The handle also acts as a barrier to prevent the lock sliding to the right. This issue highlighted that the handle could be depressed so far that the lock could be slipped off the locking shaft. See image below

- With immediate effect, it instructed all unit managers to investigate, by trial, whether they can depress their Socomec isolators handles far enough to slip the padlock off. A padlock must be applied, and physical trial undertaken.
- A sign off sheet must be provided stating the isolator name, date, time and the result of the test.
- Any isolator found to be faulty will be marked using defective equipment documentation and a plan put in place to rectify the problem.
- Contact will be made with the OEM to find permanent solution.

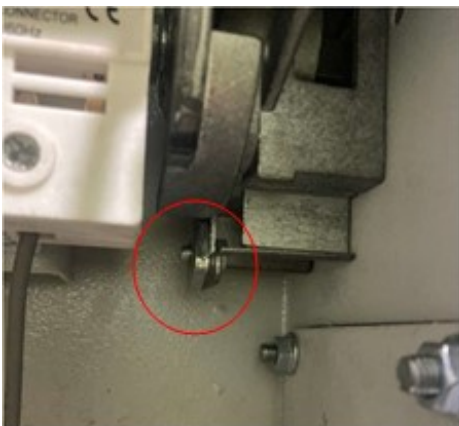
During a thorough investigation it was discovered that a square nut, which is intended to prevent the handle being depressed past its limit, had become loose and moved. This meant that the handle could be depressed further than intended, this allowed the padlock to 'slip' off.
