# Fatal 5 – Operator was struck in face by tool that fractured his cheek whilst he was clearing material in pre-heater tower

LOCATION: CEMENT PLANT  
ACTIVITY: MAINTENANCE & HOUSEKEEPING  
SUB ACTIVITY: KILNS

ALERT STATUS: Normal  
DATE ISSUED: 17/01/2024 20:07:03  
INCIDENT No: 03691

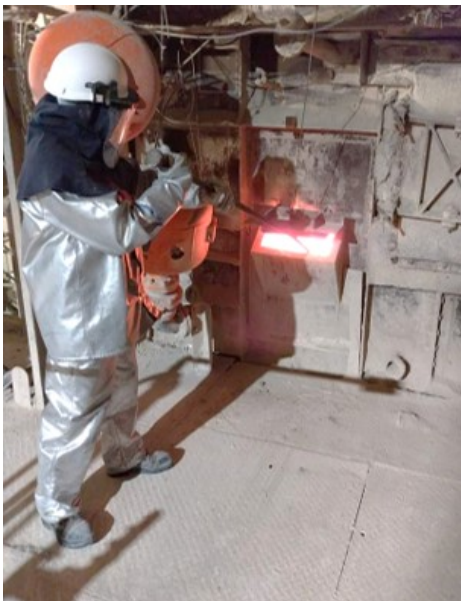
Whilst clearing the door with the specifically designed tool, a lump of build-up fell within the PHT duct and hit the bar, causing the end that the injured person (IP) was holding to deflect towards his face, resulting in a fracture to the cheek bone.

**Tools & Equipment** - The IP was using the specifically designed rodding equipment for the task. The tools were in good condition.

**PPE** - The IP was wearing the correct PPE for the task, including face visor. This ultimately reduced the severity of the injuries sustained.

- No specific action has been identified to reduce the likelihood of this occurrence. The preheater process was operating in steady state. The cleaning activity was completed as per procedure.
- Remote or robotic equipment that would reduce the need for human interaction in this task would eliminate the risks associated. Whilst technology is advancing rapidly, there is currently no remote or robotic solution available on the market that would work in the high temperature environment of the pre-heater ducting.
- Due to the fundamental design of this preheater tower (2 stage with twin double deflectors), plus 80% + alternative fuel usage, it is acknowledged this increases the risk for buildup and material falls in the PHT.
