Fatal 5 - Operatives have near miss when the operation to unload an irregular shaped and heavy load failed

ALERT STATUS: High Potential
DATE ISSUED: 07/02/2024 14:27:02
INCIDENT No: 03694

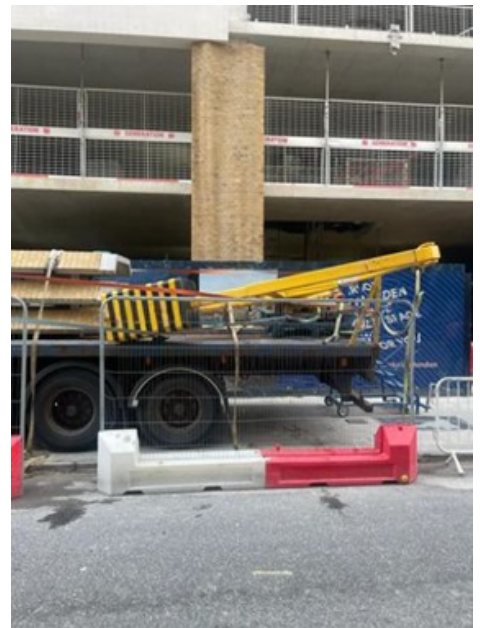
Having removed these straps, he then asked two trained lifting operatives, who were on the back of the trailer bed and were standing on the driver side of the bed, to release a third strap that was attached to the Combi-Steker through the master link. When the final strap was released by one of these operatives, it tipped over to the off side of the trailer. Its fall was arrested when it contacted the edge protection top rail. Fortunately, nobody was hit by the beam and the edge protection did not give way which could have resulted in a more serious outcome. The images below were taken at the site.

- The immediate cause of the NMI was the release of the transport retaining straps from the Combi-Steker counterbalance lifting beam before it was connected to the site tower crane. This allowed the Combi-Steker to rotate in an uncontrolled manner.
- It was established that the load had shifted during transport.
- The route cause of the incident was that there was no loading process/method in place for the counterbalance beam.
- The operative who loaded the Combi Steker onto the flat bed did what he believed to be correct without knowing what the site team would do when unloading.
- There were no instructions provided by the original supplier of the Combi Steker that showed how it should be safely loaded and how it should be secured it to a trailer.

- After the incident, the supplier was contacted, and an SOP was created that would show how to load and unload safely the counter balance beam.
- Training was given to the loading operatives and the site team operatives for unloading and reloading when returning it back to the yard once the task was completed.
