# Fatal 5 - Operatives have near miss when the operation to unload an irregular shaped and heavy load failed

**ALERT STATUS:** High Potential  
**DATE ISSUED:** 07/02/2024 14:27:02  
**INCIDENT No:** 03694

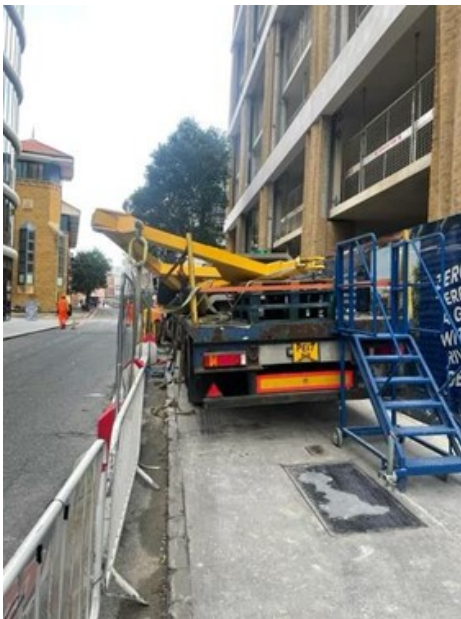
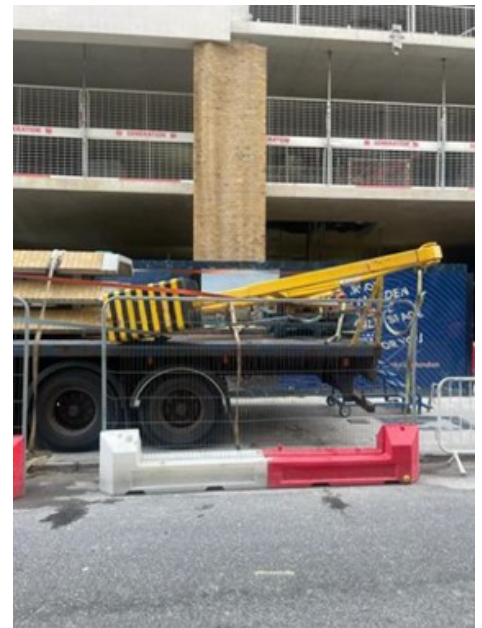
Having removed these straps, he then asked two trained lifting operatives, who were on the back of the trailer bed and were standing on the driver side of the bed, to release a third strap that was attached to the Combi-Steker through the master link. When the final strap was released by one of these operatives, it tipped over to the off side of the trailer. Its fall was arrested when it contacted the edge protection top rail. Fortunately, nobody was hit by the beam and the edge protection did not give way which could have resulted in a more serious outcome. The images below were taken at the site.

- The immediate cause of the NMI was the release of the transport retaining straps from the Combi-Steker counterbalance lifting beam before it was connected to the site tower crane. This allowed the Combi-Steker to rotate in an uncontrolled manner.
- It was established that the load had shifted during transport.
- The root cause of the incident was that there was no loading process/method in place for the counterbalance beam.
- The operative who loaded the Combi Steker onto the flat bed did what he believed to be correct without knowing what the site team would do when unloading.
- There were no instructions provided by the original supplier of the Combi Steker that showed how it should be safely loaded and how it should be secured to a trailer.

- After the incident, the supplier was contacted, and an SOP was created that would show how to load and unload safely the counter balance beam.
- Training was given to the loading operatives and the site team operatives for unloading and reloading when returning it back to the yard once the task was completed.
