# Fatal 3 - The faulty installation of a fall protect system on a chimney ladder had put operators at risk until error was picked up during inspection

LOCATION: CEMENT PLANT  
ACTIVITY: ACCESS & EGRESS & WORKING AT HEIGHT  
SUB ACTIVITY: N/A

**ALERT STATUS:** High Potential  
DATE ISSUED: 29/05/2024 12:56:44  
INCIDENT No: 03712

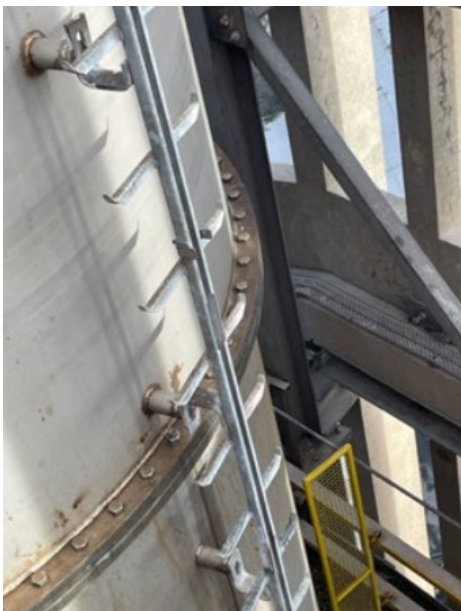
A chimney access ladder had an inbuilt rail to allow a person to attach a fall protection harness. During a recent inspection of the chimney, it was discovered that the first 5 metre section of the ladder had been installed upside down.

As a result of the faulty installation, the slot in the rail where a person would normally insert their lanyard was 4 metres above ground level instead of 4 feet as it should be. However, it was still possible to clip onto the rail at the bottom of the ladder by inserting the clip into the open end of the rail. The consequence of this is that people have been using the system for several years unaware of the installation defect. It was possible that, as they passed the slot in the rail 4 metres above the ground, their lanyard could fall out of the rail without them noticing, leaving them with no fall protection as they climbed the chimney.

The chimney ladder with the integral fall protection rail was installed by a contractor who was not a registered or trained installer of this bespoke safety system.

The image below shows the ladder, the section where a lanyard could fall from the rail can be seen around the middle of the picture.

- Bespoke safety systems should always be installed (or moved to a new location) by companies that are trained / registered installers.
