# Fatal 3 - Driver exposed to risk of fall from height after striking his head on scaffold pole while on loading gantry

LOCATION: LIME & SLAG PLANTS  
ACTIVITY: ACCESS & EGRESS & WORKING AT HEIGHT  
SUB ACTIVITY: N/A

**ALERT STATUS:** High Potential  
**DATE ISSUED:** 03/06/2024 13:40:03  
**INCIDENT No:** 03714

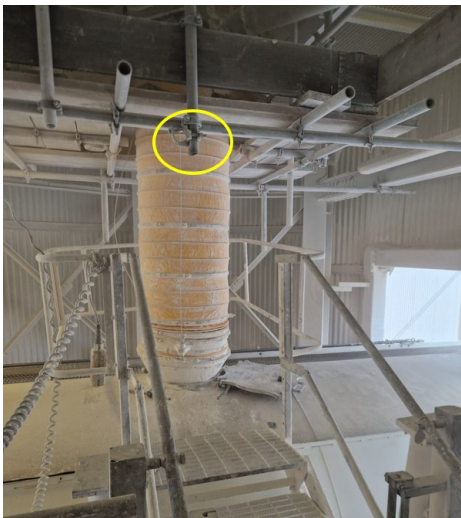
However scaffold tube ends and horizontals, protruding into the path of users were not recognized or controlled.

A driver, who was wearing the full site requirement for PPE including hard hat, bumped their head on the scaffold which potentially could have caused the driver to become dazed and fall or trip in an elevated position close to stairs. the image below shows the pole which was hit by his helmet.

A change in the risks associated with the area were not assessed following a maintenance task and as such the scaffold hazard was not identified or controlled.

- The use and erection of scaffold should consider its effect on others in the area and not just the user who would likely be positioned on the structure and not be aware of hazards created below it.
- Consider whether the task is complete if scaffold is still in place..... is allowing users back into the area while maintenance scaffold is still in place safe. (Should scaffold be removed before normal activities are resumed wherever possible).
- Scaffold left in place should be inspected to ensure it imposes no added level of risk to other employees / contractors and consider a minimum standard of fitting hi vis bump end caps and or tube covers in areas where access is likely and or common.
