# Fatal 3 - TRANSPORT - Contractor falls from ADT steps and fractures his wrist

**ALERT STATUS:** High Potential  
**DATE ISSUED:** 17/06/2024 20:15:15  
**INCIDENT No:** 03718

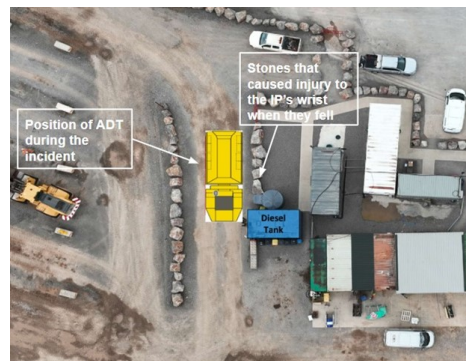
The image below shows the position of the ADT when refuelling

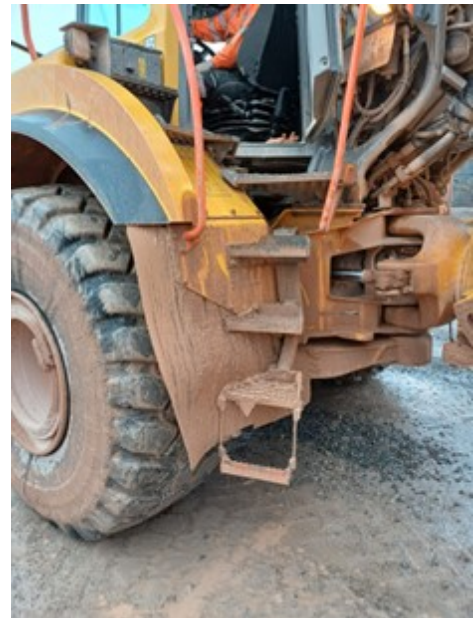
Image of the steps on the ADT

- During the investigation it was found that there was no risk assessment in place for re-fuelling the ADT
- The IP was carrying gloves while descending the vehicle steps
- The IP used unsuitable gloves for re-fuelling.

- Consider if the following are in place for your sites:
  - Risk assessments for all tasks including suitable PPE
  - Suitable gloves at re-fuelling points
  - Roll out of slips, trips and falls TBT to employees and contractors
