Fatal 3 - TRANSPORT - Contractor falls from ADT steps and fractures his wrist

ALERT STATUS: High Potential
DATE ISSUED: 17/06/2024 20:15:15
INCIDENT No: 03718

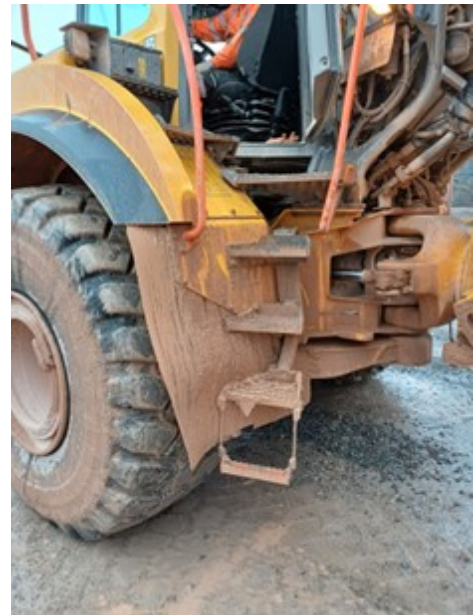
Image of the steps on the ADT

- During the investigation it was found that there was no risk assessment in place for re-fuelling the ADT
- The IP was carrying gloves while descending the vehicle steps
- The IP used unsuitable gloves for re-fuelling.

- Consider if the following are in place for your sites:
 - Risk assessments for all tasks including suitable PPE
 - Suitable gloves at re-fuelling points
 - Roll out of slips, trips and falls TBT to employees and contractors
