# Fatal 3 - TRANSPORT - Contractor falls from ADT steps and fractures his wrist

**LOCATION:** QUARRY  
**ACTIVITY:** ACCESS & EGRESS & WORKING AT HEIGHT  
**SUB ACTIVITY:** N/A

**ALERT STATUS:** High Potential  
**DATE ISSUED:** 17/06/2024 20:15:15  
**INCIDENT No:** 03718

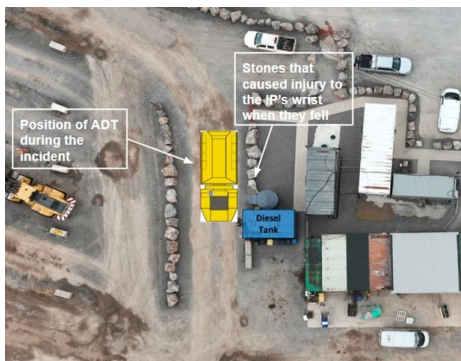
The image below shows the position of the ADT when refuelling

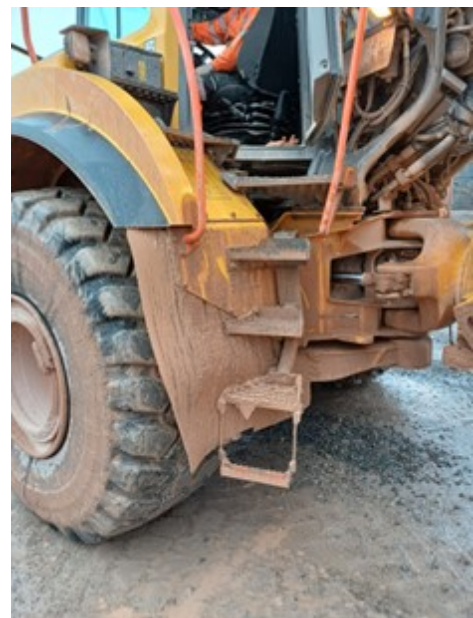
The IP's primary role was operating an ADT, moving material from the contract crushing operation to stockpiles. The incident occurred in the morning when the IP moved the Volvo A45 ADT to the site fuel tank in order to refuel. After refuelling, the IP ascended the steps to the machine cab. At an approximate height of 1450mm the IP slipped, lost his handhold, and fell. The IP then got back into the ADT, drove it to the parking area, and then reported the incident to the site supervisors who arranged for the first aider to assess him. The IP was driven to A&E, where he was treated for a fractured right wrist and swelling to a knee.

Image of the steps on the ADT

- Consider if the following are in place for your sites:
  - Risk assessments for all tasks including suitable PPE
  - Suitable gloves at re-fuelling points
  - Roll out of slips, trips and falls TBT to employees and contractors
