Fatal 5 - A silt retaining wall collapses at wharf

LOCATION:	WHARF	ALERT STATUS:	High Potential
ACTIVITY:	PRODUCTION AND PROCESSING	DATE ISSUED:	18/06/2024 15:34:37
SUB ACTIVITY:	SHIP TO SHORE	INCIDENT No:	03719

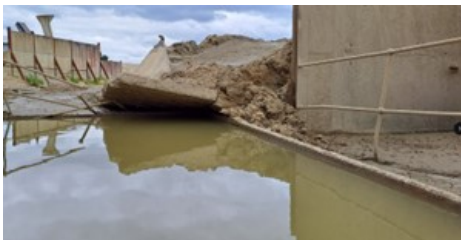
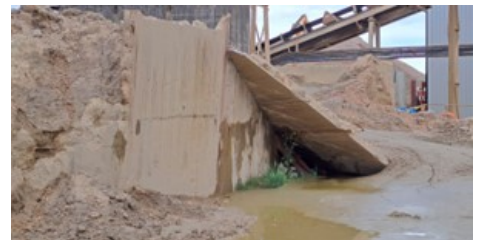
The incident occurred at an aggregates wharf in May 2024. The concrete retaining wall was used for retaining wet silt. The incident occurred in the morning after some additional material had been added to the stockpile. An hour later the concrete retaining wall collapsed, the wall struck the edge protection around the area allowing silt to flow out of the stockpile area. No material left site or obstructed any walkways. The area was cordoned off to allow an investigation to take place.

The images below show the concrete wall structural collapse and damage to edge protection to silt bays May 2024

- Have you completed all required actions, including observations with recommended actions?
- If issues are found, discuss with your regional engineer to ensure they are assessed by a competent person on a regular basis in line with your Structural Inspection Standard.
- Referring to Stockpiles, Excavations and Tips. Do your rules include the capacity for all the volume and type of material you intend to store on site?
- Ensure appointments and associated forms such as weekly/month inspections scheduled are completed;
- Discuss with your Geological Team member and update your system with any findings that you discover regarding stockpile designs.
