# Fatal 3 - Operator falls through unsecured section of steel mesh flooring

**LOCATION:** CONCRETE PRODUCTS PLANT  
**ACTIVITY:** ACCESS & EGRESS & WORKING AT HEIGHT  
**SUB ACTIVITY:** N/A

**ALERT STATUS:** Normal  
**DATE ISSUED:** 08/07/2024 14:54:47  
**INCIDENT No:** 03723

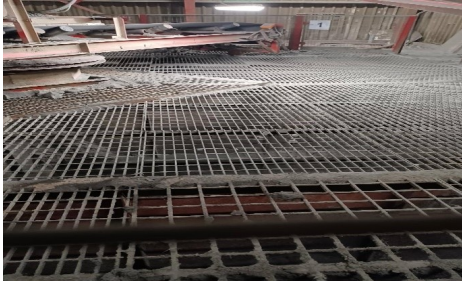
A Potentially Severe Event (PSE) occurred at a concrete products site when an employee fell through an unsecured section of steel mesh flooring above an aggregate hopper, the image below shows the flooring. The employee escaped with minor injuries, but these could have been much more serious or even fatal. Following this incident, which occurred in early 2022, the company undertook a series of actions which are summarised in the section below.

- Site Managers to plan a stand down to communicate the safety alert, highlighting the severity of the incident and actions to be taken.
- Site Managers to organise an initial and immediate observation of metal grid flooring/steps (internal/external) to identify signs of damage, ie corrosion, dislodgement, missing fixing clips (with potential for movement/dislodgement of grids) and to restrict access to these areas while awaiting repair.
- All sites with grid flooring above aggregate bins must control entry into them until all grids are inspected and made secure.
- All Business Leads to communicate back to head of health and safety on immediate actions.

- A Steering Committee has been established to review lessons learnt, introduce new control measures and review suitability of flooring.
- A standard inspection and assessment form is being established by the engineering and SHE departments.
- A compliance schedule for mandatory inspections will follow.
- External structural inspectors to be sourced where specialist advice is required.
- A review of monitoring controls to prevent overfill of hoppers.

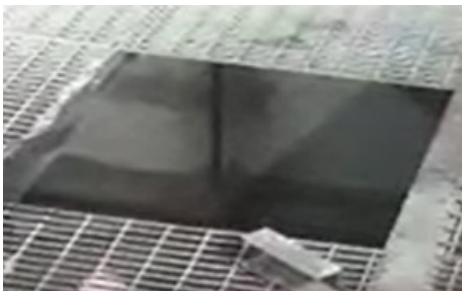
The picture below shows the opening that the employee fell through when the grid became dislodged due to previous overfill of the hopper.
