# Fatal 3 - Operator falls through unsecured section of steel mesh flooring

**LOCATION:** CONCRETE PRODUCTS PLANT  
**ACTIVITY:** ACCESS & EGRESS & WORKING AT HEIGHT  
**SUB ACTIVITY:** N/A

**ALERT STATUS:** Normal  
**DATE ISSUED:** 08/07/2024 14:54:47  
**INCIDENT No:** 03723

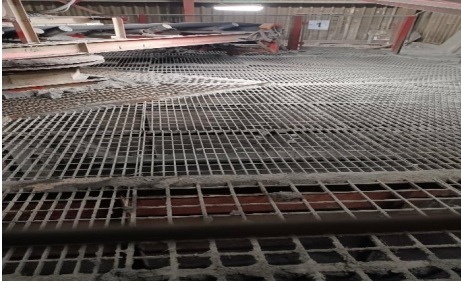
A Potentially Severe Event (PSE) occurred at a concrete products site when an employee fell through an unsecured section of steel mesh flooring above an aggregate hopper, the image below shows the flooring. The employee escaped with minor injuries, but these could have been much more serious or even fatal. Following this incident, which occurred in early 2022, the company undertook a series of actions which are summarised in the section below.

- Site Managers to plan a stand down to communicate the safety alert, highlighting the severity of the incident and actions to be taken.
- Site Managers to organise an initial and immediate observation of metal grid flooring/steps (internal/external) to identify signs of damage, ie corrosion, dislodgement, missing fixing clips (with potential for movement/dislodgement of grids) and to restrict access to these areas while awaiting repair.
- All sites with grid flooring above aggregate bins must control entry into them until all grids are inspected and made secure.
- All Business Leads to communicate back to head of health and safety on immediate actions.

- A Steering Committee has been established to review lessons learnt, introduce new control measures and review suitability of flooring.
- A standard inspection and assessment form is being established by the engineering and SHE departments.
- A compliance schedule for mandatory inspections will follow.
- External structural inspectors to be sourced where specialist advice is required.
- A review of monitoring controls to prevent overfill of hoppers.

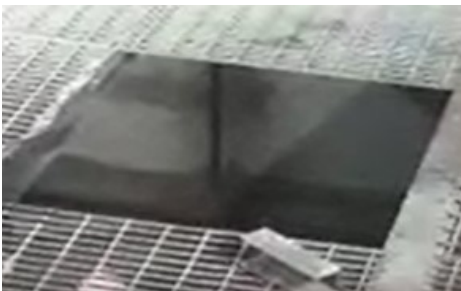
The picture below shows the opening that the employee fell through when the grid became dislodged due to previous overflow of the hopper.
