# A maintenance inspection of bitumen tank uncovers severe corrosion at base of tank

**LOCATION:** ASPHALT/COATING PLANT  
**ACTIVITY:** MAINTENANCE & HOUSEKEEPING  
**SUB ACTIVITY:** ASPHALT & COATED STONE

**ALERT STATUS:** High Potential  
**DATE ISSUED:** 19/08/2024 15:45:04  
**INCIDENT No:** 03729

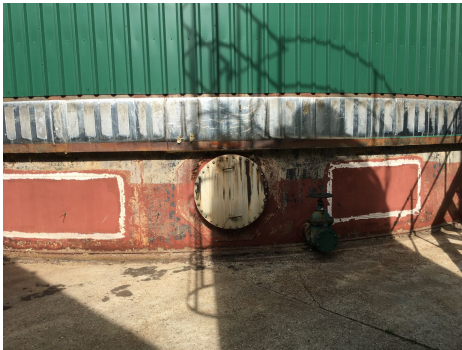
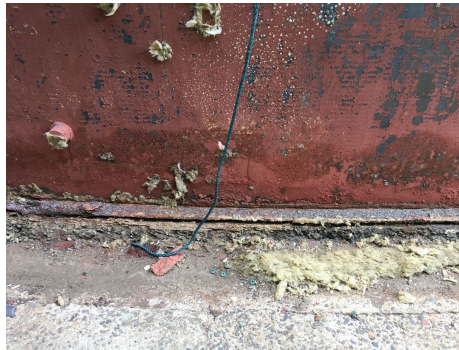
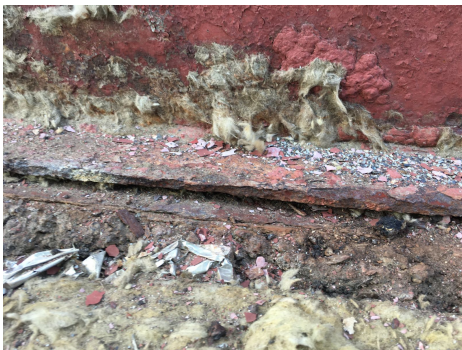
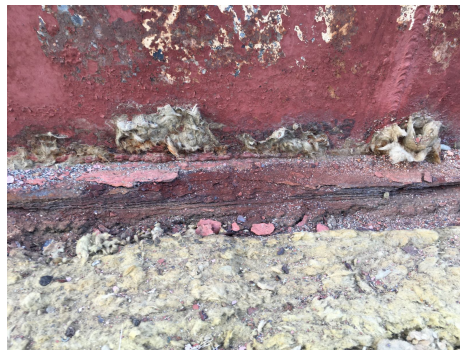
Significant corrosion was discovered at on the steel at the base of the tank walls and further inspection revealed that the thickness of the tank wall had decreased by 75%.

This was due to moisture ingress into the insulation of the tank, with the combination of heat, water and oxygen causing significant corrosion. The images below show the corrosion at the base of the tank.

There are two possible actions to mitigate the effects of moisture on the tank walls:

- Removal of insulation from the base of the tank (100-150mm)
- Incorporation of stainless steel, rather than mild steel for the bottom 1.5m of the tank walls.
