Failure of CMC Aerial Platforms - UV145 MEWP Boom

ALERT STATUS: Normal
DATE ISSUED: 20/12/2013 06:45:53
INCIDENT No: 00373

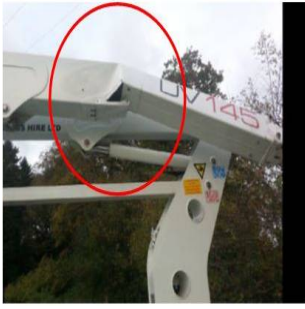
MEWP Failure

An overhead line team were working from a Mobile Elevated Work Platform (MEWP) when the main boom (arm) of the device failed. This resulted in the platform dropping and twisting through 45 degrees. The operatives working from the platform were fully attached and no injuries were sustained.

The type of vehicle that the platform was mounted on is simply an example; investigations have shown that the failure was due to a manufacturing defect which has been found on similar MEWPs.

Everyone: Look out for CMC MEWPs in your work environment. If you identify this type of MEWP on your site you must not use it and report it to your Supervisor.

If you have hired a MEWP for your site ensure it is not manufactured by CMC. It is recommended that any CMC MEWP should be returned to the hire company

If you own this type of platform contact CMC direct immediately for further advice
