# Failure of tipper's sheeting arm whilst driving on motorway

ALERT STATUS: Normal  
DATE ISSUED: 25/02/2015 00:30:20  
INCIDENT No: 00405

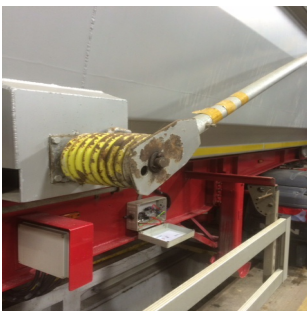
Figure 1

On later inspection it was found that the spilt pin had sheared and the washer had fallen off.

The bottom end of the sheeting arms and the attached springs are held on the mounting spigot by a large washer and split pin (see figure 1). The sheeting arms on either side of the body are joined together by a cross member bar which is attached by an elbow joint on either end (see figure 21). The sheet/net is also attached to this cross member at one end and to a spindle at the headboard which is operated by the sheeting motor.

All vehicle sheeting systems visually checked and drivers instructed to ensure sheet is in closed position when vehicle not in use. This will prevent the springs from being under prolonged tension and enable drivers to carry out more extensive checks.

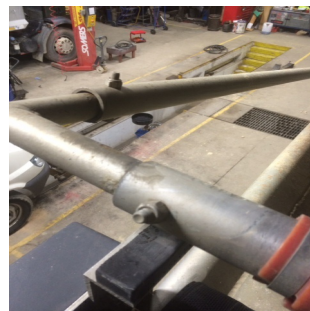
Figure 2

The offside end of the cross member sheared off at the elbow joint thus causing the offside sheeting arm to become detached from the cross member. As the arm was under tension from the spring, this caused the arm to swing towards the end of the trailer. In normal circumstances the complete mechanism would be released towards the rear of the trailer slowly as the sheet is fed out by the motor. It would then come to rest with a cross member located in the brackets at the top of the tailboard. As the offside sheeting arm was only attached to the trailer by the spigot it swung right down until the end of the arm hit the road.

Discuss incident report, together with design and use procedures, with the system manufacturers. Investigate the fitting of side to side automatic sheeting systems on new vehicles.
