Failure of tipper's sheeting arm whilst driving on motorway

LOCATION:	ON-HIGHWAY	ALERT STATUS:	Normal
ACTIVITY:	TRANSPORT & LOGISTICS / DELIVERY	DATE ISSUED:	25/02/2015 00:30:20
SUB ACTIVITY:	ON-HIGHWAY	INCIDENT No:	00405

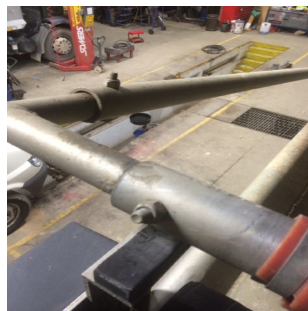
Figure 2

The offside end of the cross member sheared off at the elbow joint thus causing the offside sheeting arm to become detached from the cross member. As the arm was under tension from the spring, this caused the arm to swing towards the end of the trailer. In normal circumstances the complete mechanism would be released towards the rear of the trailer slowly as the sheet is fed out by the motor. It would then come to rest with a cross member located in the brackets at the top of the tailboard. As the offside sheeting arm was only attached to the trailer by the spigot it swung right down until the end of the arm hit the road.
