LOCATION:	READYMIX OR MORTAR PLANT	ALERT STATUS:	Normal
ACTIVITY:	MAINTENANCE & HOUSEKEEPING	DATE ISSUED:	02/10/2024 11:09:02
SUB ACTIVITY:	TANKS, KETTLE DRUMS AND PIPING	INCIDENT No:	04834

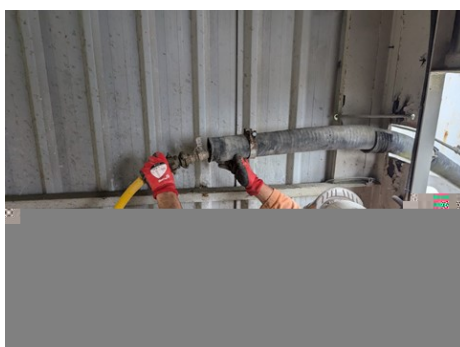
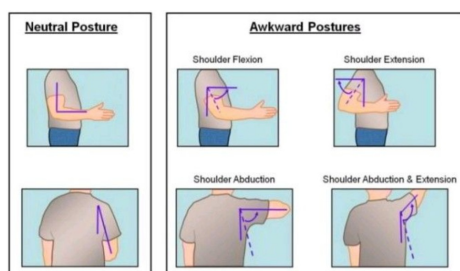
Initial Investigations indicated that the IP was undertaking a non-routine activity on site following maintenance on the recycled water tank pump. A stop assessment was conducted for the priming process. The IP proceeded to use a high-pressure water hose pipe to prime a 3" recycled water pipe. During the procedure the high-pressure hose unexpectedly recoiled whilst under high pressure, resulting in the IP's arm being forced backwards causing an injury to their shoulder.

Please see below two images that show the position of the contractor when the incident occurred.

- Check, confirm and review poor design which may cause positions of overreaching to ensure that ergonomic risks are considered and relevant controls are identified and implemented prior to the commencement of work.
- A stop assessment is not an adequate control measure for a non-routine task. A full Risk Assessment must be completed prior to work.
- Contractor management must include checks to ensure work is completed appropriately and in an operational state.
- Awkward postures refer to unnatural body positions, such as bending, twisting, or overreaching e.g. as seen below. These positions force your joints beyond their normal range of motion, significantly increasing the risk of ergonomic injuries.
