**Gasket failure at an asphalt plant resulted in a bitumen spill. Some of the bitumen, which was at a temperature of circa 130 - 140 degrees, enveloped an airline that ruptured causing a spray of the bitumen.**

**LOCATION:** ASPHALT/COATING PLANT  
**ACTIVITY:** MAINTENANCE & HOUSEKEEPING  
**SUB ACTIVITY:** ASPHALT & COATED STONE

**ALERT STATUS:** Normal  
**DATE ISSUED:** 21/10/2024 15:52:13  
**INCIDENT No:** 04840

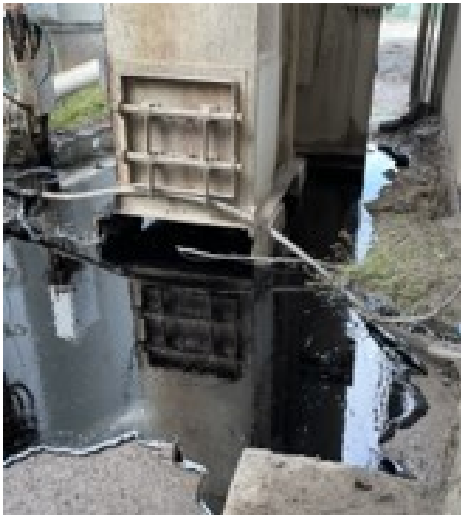
A failure in the bitumen trace heating system on an asphalt plant resulted in the pipework cooling. After the trace heating was repaired the pipework was brought back to the operating temperature. The plant was then started successfully, mixing 6 tonnes without any problems. However, as the manager passed by the bitumen system, he observed bitumen leaking beneath the pump cover box. He promptly notified the plant operator, leading to the shutdown of the equipment. It was also discovered that some of the bitumen, which was at a temperature of circa 130 - 140 degrees, had enveloped an airline that ruptured causing a spray of the bitumen. See full incident alert for more information.
