Fatal 5 - Quarry face collapse during drilling operation

ALERT STATUS: Normal
DATE ISSUED: 29/10/2024 11:54:56
INCIDENT No: 04841

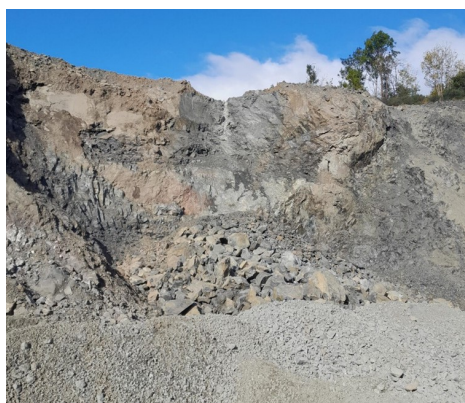
A drilling contractor was on-site at a quarry and whilst drilling the first row of holes, the face collapsed with approx. 100 tonnes of material falling to the quarry floor.

Fortunately, the drill rig and operator managed to get to a place of safety quickly and sufficient bunds were in place at the bottom of the face which contained all of the material that fell.

Upon investigation, it was found that there was a seam of dark brittle material which when drilled caused a plane failure. This had been highlighted in the most recent geotechnical assessment and had been placed on a site specific geotechnical action plan, but neither of these documents had been checked prior to the drilling being carried out. The image below shows the face collapse.

- Ensure all safety control measures are in place before drilling begins (i.e. suitable rock traps, safe stand off at drilling area etc.)
- Ensure the most recent geotechnical assessment report and action plan are available and have been checked for any areas of instability or potential areas of failure where drilling is taking place.
- Ensure a suitable standoff is maintained by the drill rig operator from the crest of the face and that the drill rig can be moved to a suitable place of safety in the event of an emergency.
- If in any doubt about the area to be drilled, STOP, and get specialist advice before proceeding.
