**Quarry Contractors – Failure by a contractor to perform an earthmoving operation at a quarry safely - highlights responsibilities of company to manage contractors undertake the task safely**

## **WHAT HAPPENED**

A contractor carrying out a quarry earthmoving campaign was required to cease operations and was expelled from the site on grounds of unsafe practices.

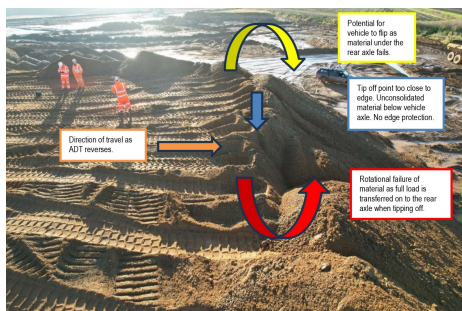
View from above the stockpiled material

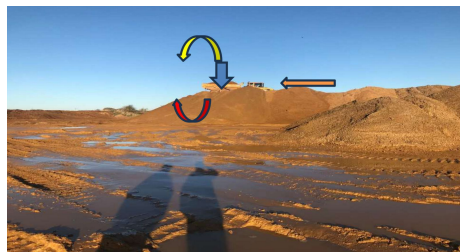
Side view of the stockpiled mineral

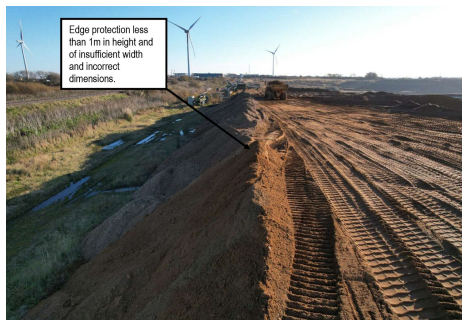
The edge protection

- On quarry benches or roads used by heavy vehicles, the minimum acceptable height of the edge protection is 1.5m or the radius of the largest wheel/tyre – **whichever is greater**. Additional protection is needed in high-risk areas, such as sharp bends or steep haul roads, where sand traps should also be considered

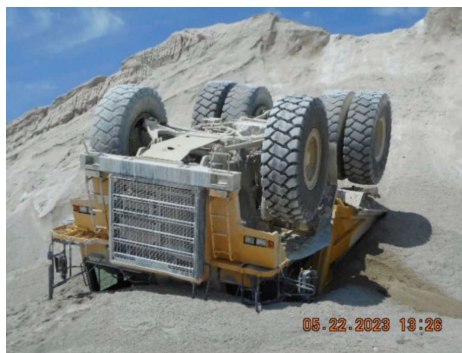
Please see below an example of **end tipping** that occurred in the USA. This incident resulted in a fatality.

Link to accident report: <https://www.msha.gov/data-reports/fatality-reports/2023/may-22-2023-fatality/final-report>

- Below are the basic parameters of good and bad edge protection, taken from Regulation 13.
- When tipping material on top of a stockpile or tip, the load must be dispensed at least 6 metres from the break in slope. A suitably sized bulldozer must then push the material over the edge, whilst maintaining their tracks on relatively compacted ground.
