BMAPA - Fire - HiPo - Discharge excavator electrical fault

ALERT STATUS: Normal
DATE ISSUED: 01/04/2025 15:10:26
INCIDENT No: 04866

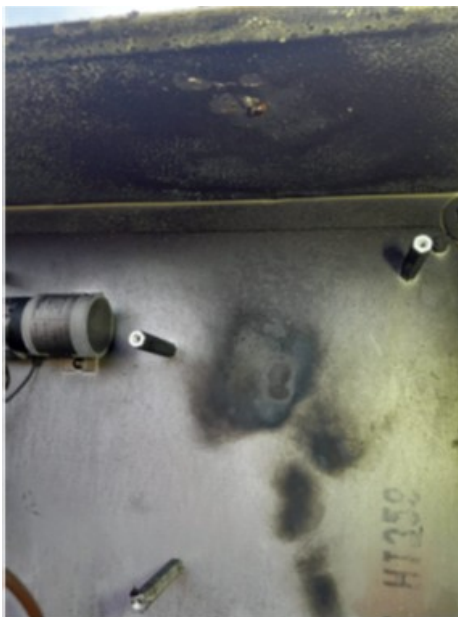
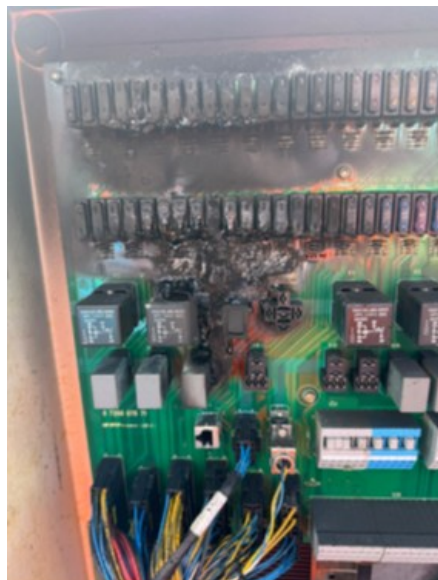
Whilst unloading a sand cargo, black smoke was seen pouring from the side panel/electrical box of the ships discharge excavator. The operator was alerted and attempted to turn off the machine by key but it failed to switch off. An attempt was made to open the side panel of the excavator. Once the black smoke had cleared no flames were identified but significant charring/melting was seen on the main electrical panel. Around 2 minutes later the engine cut out on the excavator and all electrical power to the cab was lost.

An investigation was carried out by an external electrical contractor. This identified that the root cause was moisture ingress into the electrical compartment of the discharge excavator as a consequence of corrosion caused by weathering and salt-water action.

At this point no extinguisher or water had been discharged and the burn/fire had self-extinguished.

- Repairs were carried out to reinstate the watertight integrity of the panel.
- In addition, the pre-start inspections were amended to include a check of panel/door structure seal integrity and ensure no water ingress visible.
