TRANSPORT - HiPo - Truckmixer drum found to be in dangerous state due to poor maintenance regime, it could easily have become detached while vehicle was on-highway

LOCATION:	READYMIX OR MORTAR PLANT	ALERT STATUS:	Normal
ACTIVITY:	TRANSPORT & LOGISTICS / DELIVERY	DATE ISSUED:	28/04/2025 17:26:36
SUB ACTIVITY:	MIXERS AND DRUMS	INCIDENT No:	04868

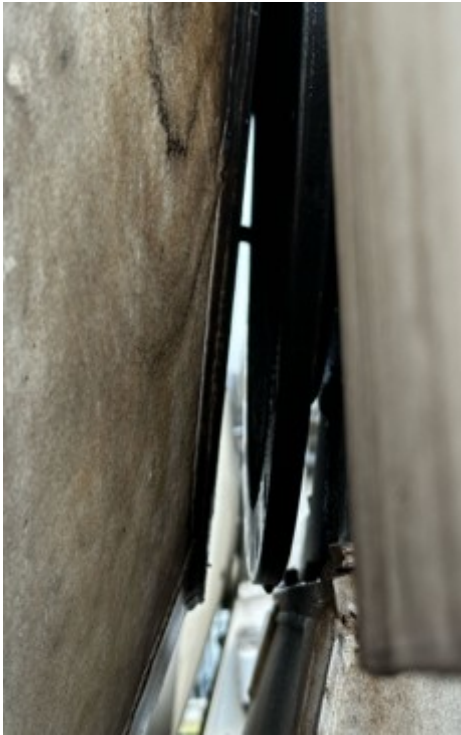
A truck mixer was being loaded with 4m³ of concrete, the first load of the day. Upon noticing a metal-on-metal noise, the driver moved away from the loading bay to investigate the issue. He discovered several of the bolts securing the gearbox and drum had sheared, leaving only three bolts holding the drum in place, see the image below. A new gearbox had been fitted less than 18 months previously.

On inspecting the remaining bolts in the flange, one was identified as a high-tensile grade 10.9 bolt which is the correct bolt for mounting the gearbox & flange to the drum, while the other was a grade 8.8 bolt, more usually found on mounting brackets that allow for movement. **This high potential (HiPo) incident could have had catastrophic consequences if the drum had become detached.**

- The truck owner's incorrect maintenance decisions highlight the need for better understanding of potential consequences of poor decisions and inspection regimes.
- Truckmixer drivers should visually inspect the mixer gearbox mounting bolts (see the image below) as part of their daily pre-use inspection, checking for signs of movement or missing bolts.

- Operators must ensure they follow manufacturers' maintenance guidance in accordance with the specific equipment operators guide (drivers handbook).
- Best practice is to have this area checked during formal documented safety inspections by the vehicle maintenance provider in accordance with a recommended truck mixer inspection sheet.
- Ensure robust defect reporting and rectification schemes are in place, which should be audited and checked by the vehicle owner. This should include procedures which require the vehicle to stop operating if critical faults are found.
