# TRANSPORT - Fatal 6 - Rollover of concrete mixer

## WHAT HAPPENED

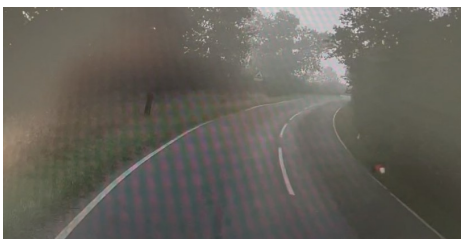
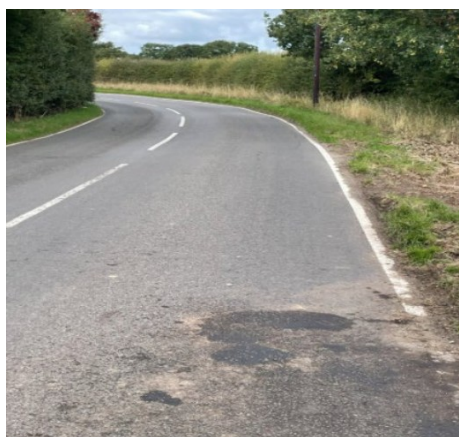
A concrete mixer truck was travelling along a rural route to a customer site when it lost control on a right-hand corner and rolled over onto a grassed area.

The route has a 50MPH speed limit with multiple changes in camber with the vehicle travelling above 40MPH when it went over.

- Lack of awareness/driving too fast for the road conditions

- Significant camber changes in road surface
- Limited warning signage on the road

The images below show the road where the rollover occurred.

- Drive to the road conditions rather than the speed limit
  - Plan journeys to ensure you take the safest route
  - Drivers to be aware of the potential dangers of entering soft verges with mixer trucks
  - Ensure there are no loose items carried in cabs
-
