BEST PRACTICE

| BEST PRACTICE No: | BP890 | COMPANY TEL: | 07803 95 3658 |

Simple visual indicators to prevent slow speed shunting collisions on railhead

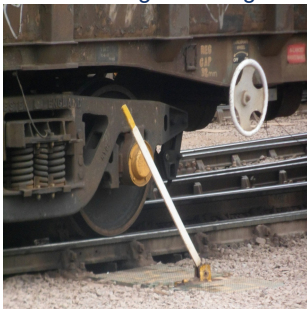
Before

In 2011 and 2012, the 3M tonne per annum railhead at Barrow on Soar experienced 3 instances of very slow speed shunting collisions within the sidings, causing damage to wagons and infrastructure and disrupting the railhead operations. The accidents were either caused by parked wagon sets 'partially fouling' points so that wagon sets on adjacent lines could not pass without touching, or were due to over shunting wagon sets into the stop blocks.

A review noted that there were no visual markers to show whether the parked sets were sufficiently clear of the points to allow safe passage. Operators were using their judgement and experience to 'visually assess' whether there was sufficient clearance. The solution was to mark back from the stop blocks and points the clearance distance by painting the track sleepers in red – creating a clear visual marker – without creating a trip hazard. The method of working was adjusted so the shunting was undertaken at normal speed until the last three wagons and then slow speed until beyond the markers.
