## Fatal 1 - Conveyor entrapment

# WHAT HAPPENED

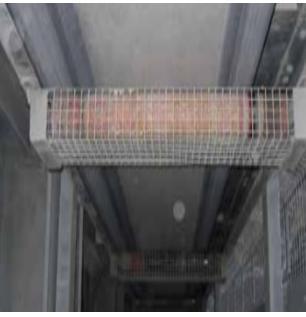
**Basket Guard**

The conveyor is approximately five years old and had been designed and built to BS EN 620 2002 and A1 2010. The design was that the return idlers were fitted with a basket guard similar to the illustration shown (Guarding of Machinery Guidance from the Quarry Products Association Aug 2005).

The guards were as designed and securely in place. Since the installation of the conveyor BS EN 620 has been updated to 2021 edition published in October 2021. Where previously it was thought that the installation of the basket guard was sufficient, BS EN 620-2021 has identified additional measures to ensure that the guarding is sufficient

The issue is that the basket guard alone may just move the in running nip point from the idler to the edge of the guard, hence the need for these additional measures.

Survey all conveyors less than 2700mm from the floor that are not totally guarded.

- Ensure restricted access via zoning for belts below 2700mm,
- Fit idlers with basket guards
- Restrict access under belting with handrailing and signage or additional guarding, up to 2700mm
- Check gap between conveyor and basket guard, which must be less than 5mm.
- Survey belt deflection near basket guards for 50mm deflection with less than 150N force.
