Buried Cable Strike

ALERT STATUS: Normal
DATE ISSUED: 13/05/2016 13:55:25
INCIDENT No: 01430

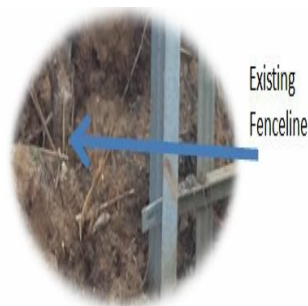
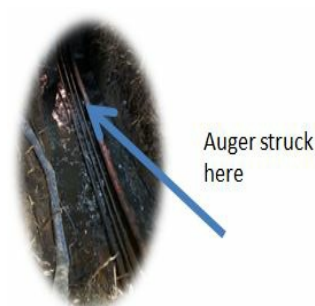
A contractor struck an 11kva cable with a mechanical auger whilst digging holes for fence posts around one of our sites. A pre-task meeting had been held and the positions of the holes and a low voltage cable on the site marked on the ground after scanning; unfortunately the contractor decided it would be easier to dig the holes further back from the agreed route, which took them into a neighbouring property and in close proximity to the high voltage cable.

A method of work had been agreed and Permit to Work and Worksafe completed. - Unknown to the site staff, the contractor decided it would be easier to dig the holes further back from the original fence line, to avoid an existing tree root, which took them into a neighbouring property.

The area they dug into had not been scanned because they were not supposed to be digging there

The contractors should have followed the instruction in the Permit to Work and method statement, digging in the prescribed locations.

Scanning of the adjacent land and access to the site plans of the neighbouring property may have increased awareness of the dangers of not following the agreed procedure.

- Ensure contractors understand that deviation from agreed Permits and methods of work is forbidden without prior approval from an authorised company Supervisor.
- Provide sufficient Supervision of contractors during these sort of tasks.
- Prior to excavating on site boundaries, consult neighbours in respect of buried service plans and scan for cables as appropriate.
