INCIDENT ALERT

LOCATION: QUARRY
ACTIVITY: MAINTENANCE & HOUSEKEEPING
SUB ACTIVITY: N/A

Catwalk failure on mobile screener

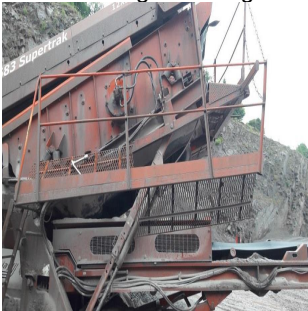
Photo 1 shows the collapsed catwalk after the incident. It is designed to fold up for transportation. Whilst this is not a new machine it was still in original condition around the catwalks. The screener was subject to regular inspection and the staff say that the catwalk was stable and gave no indication that it was likely to collapse before the incident. There was no movement, sway or bounce when it was in use.

- Both screeners had remedial repairs undertaken using a heavier gauge steel than the original construction to prevent future damage.
- Inspect similar equipment for defects and take remedial action where necessary.
- Amend inspection regimes to include an examination for this type of fault, where necessary.

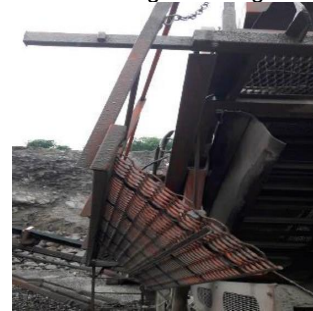
Photo 2 shows the catwalk collapsed in on the rail that should support it.

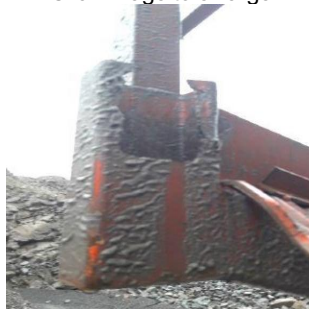
Photo 3 shows the area where the walkway upright tore away from the support rail. Both the supports for the catwalk were damaged in the incident. A thorough examination of the other catwalk showed a hairline crack in the metal beside the weld once the paint was removed. Another screener was inspected following this incident and it was found to have a 10mm hairline tear in the steel at one of the upper supports once the paint was removed. Continued vibration during use appears to be the reason for the damage occurring.
