INCIDENT ALERT

TITLE

Operatives hand injured during planing operation

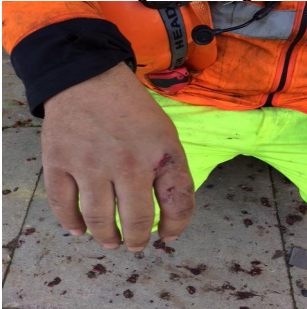
An operative was carrying out his duties on-site as a planer banksman. Whilst the asphalt planings were being conveyed into a lorry, a piece of breakout asphalt (weighing approximately 2.4kg) bounced off the side of the lorry and struck the operative. He suffered a small cut to his right-hand index finger just above the knuckle. Immediately after the incident, the following actions were taken.

Injured hand

- Planing operation was stopped
- Injured person received first aid
- Site supervisor and management team informed of incident
- IP later attended hospital for medical assessment
- SHEQ representative contacted for further advice

1. Full investigation to be conducted by the Surfacing Divisions (assisted by the SHEQ Department) with all relevant documentation provided to Central Services.
2. Workforce to be informed to keep danger zones free and clear of persons, maintaining visibility at all times and to heighten awareness.
3. Review of possible safety protection systems to control hazard e.g. falling debris

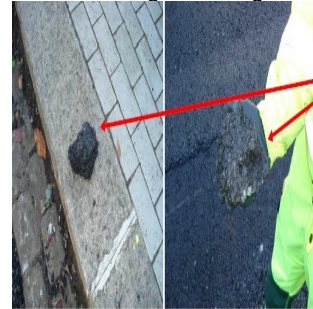
Asphalt lump

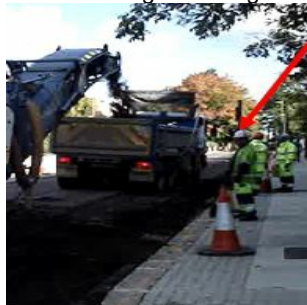
The image illustrates the position of the operative relative to the lorry and conveyor when he was struck by the asphalt.

Operative position
