## INCIDENT ALERT

<b>LOCATION:</b>	<b>CONCRETE PRODUCTS PLANT</b>	<b>ALERT STATUS:</b>	<b>Normal</b>
<b>ACTIVITY:</b>	<b>MAINTENANCE &amp; HOUSEKEEPING</b>	<b>DATE ISSUED:</b>	<b>19/03/2019 13:00:36</b>
<b>SUB ACTIVITY:</b>	<b>N/A</b>	<b>INCIDENT No:</b>	<b>01509</b>

**Fatal 6 – Employee enters hopper without PTW or Isolating**

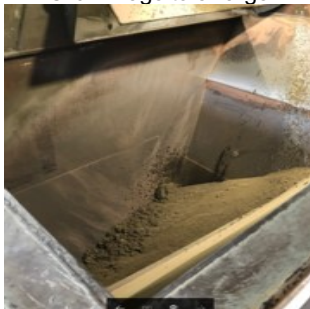
An employee entered a hopper below the mixer to start clearing out material that was going hard due to a conveyor belt failure underneath, without following the correct site procedures.

The mixer hopper is classed as an enclosed space and therefore no entry to this area is allowed without isolating the press conveyor belt and also being issued with a Permit to Work.

The Works Manager went to the check on the job and found the employee inside the hopper. As he knew there had not been a Permit to Work issued, the job was stopped immediately. Whilst being subsequently interviewed, the employee admitted that he was also not personally locked onto the conveyor belt isolation.

**Hopper the employee entered**

- The employees should have followed the essential safety procedures, rather than allow their urgency to leave site for personal reasons to affect their behaviour.
- The second observing employee could have stepped in to prevent his colleague entering the hopper without a permit to work.

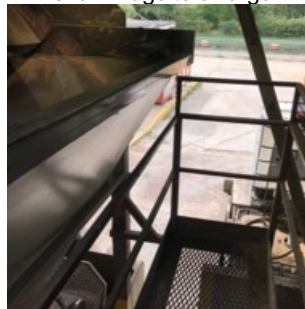
A second employee who was fully aware that a Permit to Work had not been issued, stood on the adjacent platform and watched his colleague enter the hopper without stepping in to stop him.

**Access platform from which other employee observed**
