# Fatal 6 - Return roller nip guard on conveyor falls 4m and hits contractor

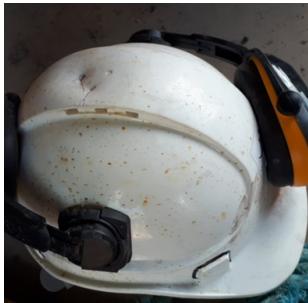
The guard weighing circa 8kg fell 4m and hit the contractor on the centre of his hard hat. Fortunately, the contractor suffered only neck and muscle strain and was able to continue working after a short period.

Hard hat with dent along back near centre

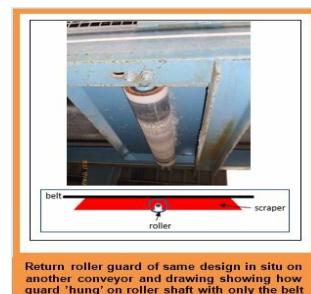
The contractor was standing under the incline conveyor belt system as he pulled the old conveyor belt through the system. During this operation an original return roller nip guard was dislodged. Investigation showed that it was designed so that it hung over the roller shaft and was only held in place by the belt and gravity.

Return roller guard of same design in situ on another conveyor and drawing showing how guard 'hung' on roller shaft with only the belt holding it down

- Check to see if this type of system is present on your site
- If they are on site, amend risk assessments / safe systems of work to include the need to check how roller nip guards, rollers and scrapers are secured
- Ensure all return roller nip guards, rollers and scrapers are securely fixed before any conveyor belt replacement work commences
- Any person carrying out a task where objects or items above them could fall should wear a hard hat, not a bump hat.
- Exclusion zones should be set up in any area where equipment is being worked on overhead
