INCIDENT ALERT

LOCATION: READMIX OR MORTAR PLANT
ACTIVITY: MAINTENANCE & HOUSEKEEPING
SUB ACTIVITY: N/A

Fatal 6 - Isolator safety device failure

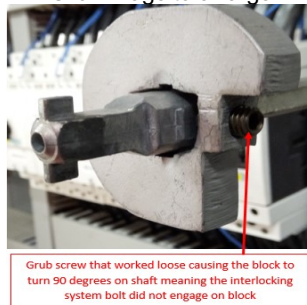
The potential for an operator to be injured existed when the mechanical locking system failed on the isolator switch for the mixer castell system. Although the operator had turned and removed the castell keys which should have locked the isolator in the 'Off' position. He discovered when implementing the 'Try Out' part of the LOTOTO system, the isolator could be turned back to the 'On' position.

An examination revealed that the block the castell key bolt should have engaged with had worked loose and turned 90 degrees. This meant that the bolt was not engaged in the recess of the block, this enabled the isolator to be moved with the keys out. The isolator switch locates on end of shaft. Block should turn with shaft if grub screw is done up correctly. See image

- All similar systems should be checked by competent person to ensure blocks are in correct position, grub screws are tight and blocks cannot move on the shaft.
- Isolators should be locked off with padlocks even if connected to an interlocking system
- Always check the isolator cannot be turned on as part of the 'Try Out' section of the LOTOTO system

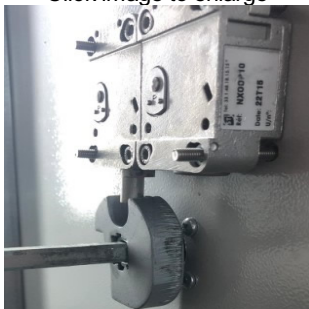
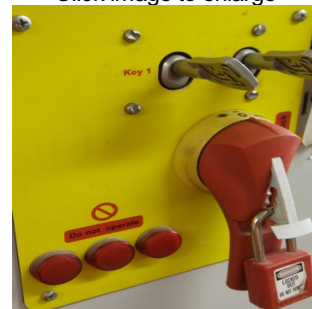
Please see images below of block with castell bolt located correctly in the top and isolator switch in off position with padlock attached.
