INCIDENT ALERT

LOCATION: ASPHALT/COATING PLANT
ACTIVITY: MAINTENANCE & HOUSEKEEPING
SUB ACTIVITY: N/A

Fatal 6 - Bitumen spill due to faulty butterfly valve

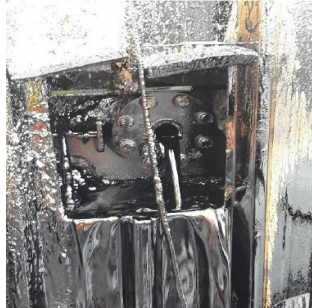
An external fitter was attempting to replace a pressure sensor probe which was situated at the bottom of a vertical bitumen tank. He removed the cover plate to gain access to the butterfly isolation valve, due to the valve handle being missing he used mole grips to turn the butterfly valve 90 degrees. He assumed because he had turned the valve until it stopped, that the valve was fully closed. This was not the case. He then loosened the damaged pressure sensor with a large adjustable spanner and started to remove it by hand. The sensor probe was easily removed but the bitumen started pouring out of behind the sensor and by then it was too late to put it back in as the butterfly valve was obviously open instead of shut. The fitter was wearing welder's gauntlets and a fireproof boiler suit but a small amount of bitumen trickled down the boiler suit into the gauntlet causing a burn covering the back of the left hand. The investigation highlighted that the butterfly valves are not suitable as there is no way of positively identifying what position the valve is in. The manufacturer is now fitting gate valves as standard instead of butterfly valves to prevent this issue.

Butterfly Valve with Sensor Probe removed

Gate valves utilise a movable gate or door to allow or prevent flow. In most cases the gate is raised or lowered using a mechanical assist of some kind – often a threaded screw. Flow is initiated by lifting the gate and prevented by lowering the gate. The following action is being taken: - All bitumen tanks to be investigated to determine which type of valve is fitted. - Butterfly valves are to be replaced with gate valves during the next pressure sensor change by a trained and competent person. - This work should only be carried out after the bitumen tank is either empty or completely cooled to reduce the risk of this incident happening again.

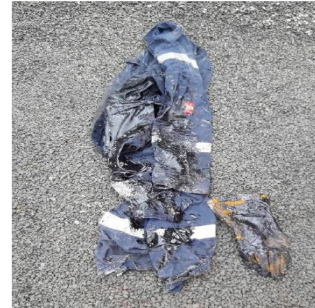
Bitumen covered PPE
