## INCIDENT ALERT

LOCATION: DIMENSION STONE PLANT  
ACTIVITY: GUARDING AND ISOLATION  
SUB ACTIVITY: NO SUB ACTIVITY AVAILABLE

Fatal 6 - Near Miss – Rotary Saw Tooth Failure

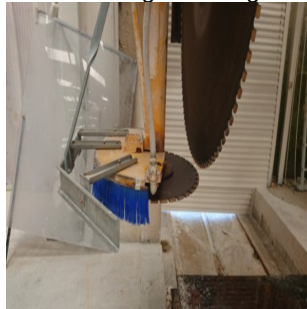
A tooth came off a small horizontal saw blade and hit the operator bruising his leg. He was standing about 4 metres from the machine at the time. Although this did not result in a lost time incident the outcome could have been a lot more serious.

Image with new guard fitted

- An adaption to the guard in stainless steel was manufactured and fitted – see image.
- This adaption is adjustable and, if a tooth should come off, it would hit the guard preventing the operator from being in the line of fire
- **Risk changers** – the company is looking at replacing the equipment with a fully enclosed machine, so the operator has no need to go into the sawing area when the blade is running.

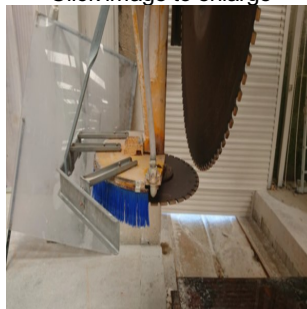
Image of new guard
