INCIDENT ALERT

ALERT STATUS: Normal
DATE ISSUED: 14/09/2011
INCIDENT No: 00311

Truck Mixer Wedged Under Bridge

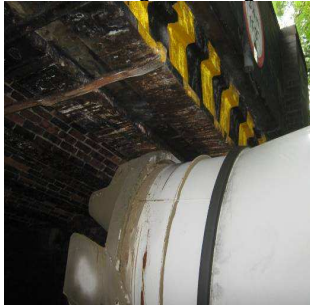
A truck mixer was carrying a load of concrete to a customer site, on route the driver encountered a low bridge and knew that it would be tight to go under the bridge, he slowed and put the vehicle in 1st gear. On exiting the bridge there was a steep incline causing the drum ring to wedge under the bridge. The vehicle could not go forwards or backwards.

The police and Network Rail were informed and the railway closed for 46 minutes until the vehicle was freed by releasing air from the tyres. The investigation has found that the bridge height indication was 11ft 3 inches and when measured, the height of the truck was 12 ft 2 inches. The driver did not know the height of his vehicle and it was not indicated in his cab.

Wedged under Low Bridge

- If a vehicles overall travelling height or trailer exceeds three meters there must be a notice in the cab, where it can be easily read by the driver.
- The notice must indicate the overall travelling height of the vehicle (to a tolerance of plus 150mm) in feet / inches or both feet / inches and meters, (but not in meters only).
- The numbers in feet/inches must be at least 40mm tall
- The requirement of the notice is not covered in an MOT test
- Importantly the driver must know the height of his vehicle and not take the risk.

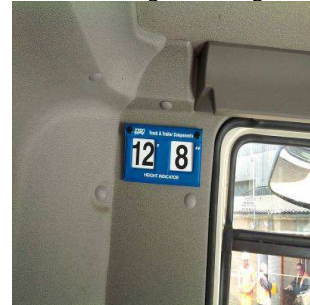
Height Indicator
